## Marine Surveys UK

Survey Report no: [REDACTED]

Type of Vessel: Jeanneau Sun Odyssey 40.3, 2004  
Sailing vessel, Bermudian Sloop rig, FRP construction.

Type of survey: Pre- Purchase

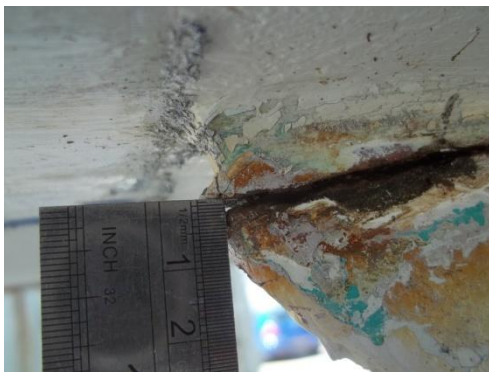
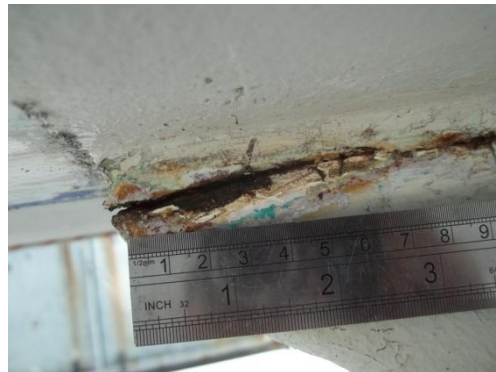
Pictures for reference

- This is an iron fin keel with large bulb at the bottom. It is attached to the flat bottom hull with at least 4 pairs and 2 single iron studs with metal plates, washers and nuts. The keel is painted with antifouling and primer.
- The keel was visually checked for damage and checked with a magnet for excess filler and none was found.
- It was noted when the boat was hanging with the keel unsupported a gap at the joint with the hull. This was 2mm at the aft end closing up to 0mm 70mm in. There were some rust stains on the keel at this point. The joint was tested with a spike all the way around every 50mm and closely visually inspected. The front edge of the keel joint was obscured by the

travel hoist slings. When the vessel was lowered onto its keel, the gap closed up. Apart from some water that squeezed from the aft end, no signs of any leaks seen on the keel while drying.

- d) Internally access was possible to all keel fixings. These had some surface corrosion; some have been painted with a blue paint, possibly rust oxide. The studs and nuts are all magnetic indicating a level of iron in the studs. The center bilge section was partially wet and the nuts here are more heavily corroded. All nuts and plates were struck hard with a hammer, none were found loose. The bilges were dried around the studs and during the sea trial no signs of any water ingress around the studs was noted.

**Advisory note:-** The gap at the aft edge is aft of any keel fixing and is common in many FRP sailing vessels with flat bottom hull and fin keel. The hull is flexing. As far as I can ascertain there are no leaks to the keel bolts. When the vessel is next lifted or (suggest winter 2011 latest) clean the aft edge of the keel and rake out the keel joint filler paste. Paint non protected iron with a protective paint, re-bed joint with Sikoflex 256.

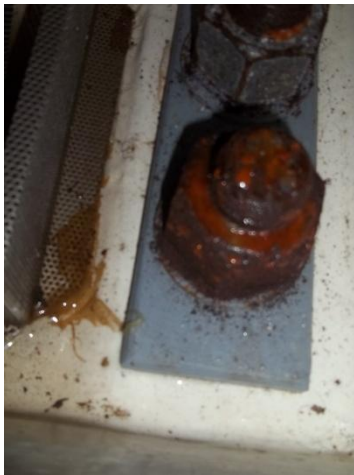
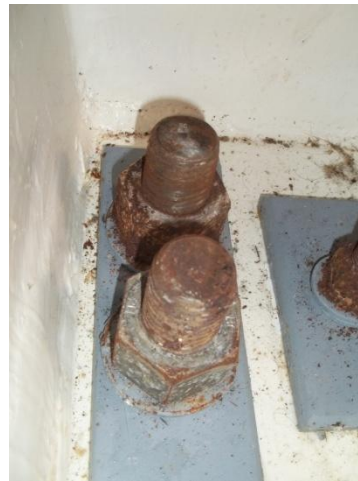
Studs in centre bilge and aft

Gap in joint for reference

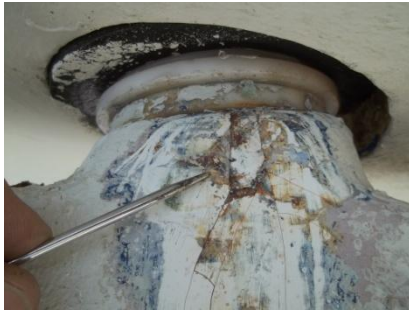
Rudder port

- c) The rudder was leant on with full body weight in either direction and forced from the bottom and it did not give or any split open up.
- d) Moisture readings were taken and the rudder tested with a hammer as per the hull for delamination. The readings were higher than the hull at 35 – 64.

- e) The top of the rudder around the rudder stock has some cracks in the gel coat. I was not able to neither insert a spike into these nor crack them off.

**Advisory note:-** When the boat is next lifted, check the top of the rudder again, grind out the cracks to solid laminate and re glass and epoxy. It is probable the high moisture readings are where water is entering at this area and sitting in the foam core. Many rudders surveyed of this construction have similar condition. If the boat is out for any length of time, drill 3 mm Ø holes through the rudder in the middle and at the bottom about 70mm up from base. Allow any water to drain out, allow drying as long as possible and then filling holes with epoxy. It is possible long term that the stainless steel in the rudder could corrode and eventually break up. There are no signs of this at present.

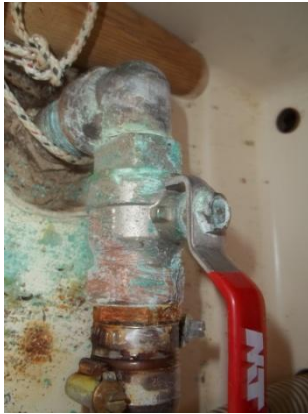
Engine valve

- a) Engine seawater inlet – Located in saloon under aft cabin sole board – Yellow metal skin fitting with ball valve and yellow metal spigot for pipe. Surface corrosion on valve body, when scraped it is slightly pink indication some dezincification.
- b) Forward heads black (toilet) waste outlet – located forward heads locker cupboard - Yellow metal skin fitting with ball valve and yellow metal spigot for pipe.
- c) Forward heads toilet water inlet – located forward heads locker cupboard - Yellow metal skin fitting with ball valve and yellow metal spigot for pipe.
- d) Aft heads black (toilet) waste outlet – located aft heads locker cupboard - Yellow metal skin fitting with ball valve and yellow metal spigot for pipe.
- e) Aft heads toilet water inlet – located under saloon sole board - Yellow metal skin fitting with ball valve and yellow metal spigot for pipe.

**Important note:** The ball valves used in this boat are believed to be made from forged brass to the European standard CW617N. Whilst these valves are in very common marine use ordinary brass such as this is subject to dezincification in seawater.

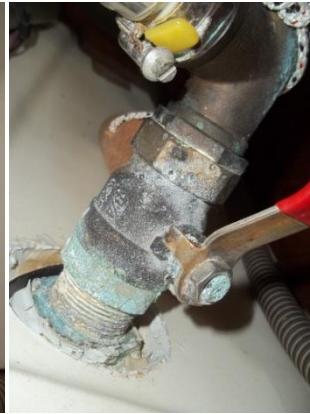
Galley valve

- i) Galley Sinks drain – located starboard side behind saloon backrest - Yellow metal skin fitting with ball valve and yellow metal spigot for pipe – both sinks attach. Slight corrosion on base of valve and ball lever spindle.
