## Marine Surveys UK

Survey Report no: [REDACTED]

Type of Vessel: Donzi 26 Regazza, 1988 USA built  
Deep V Hull, FRP (Fibre Reinforced Plastic) Sports  
motorboat

Type of survey: Pre-purchase and Valuation

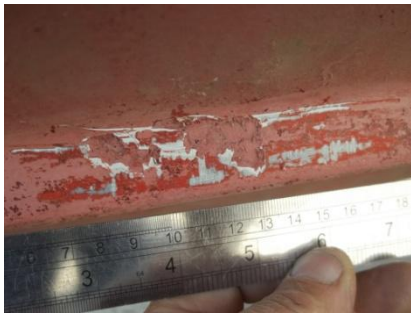
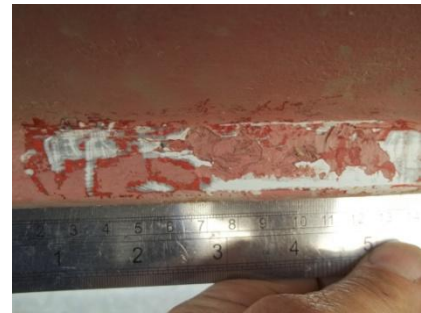
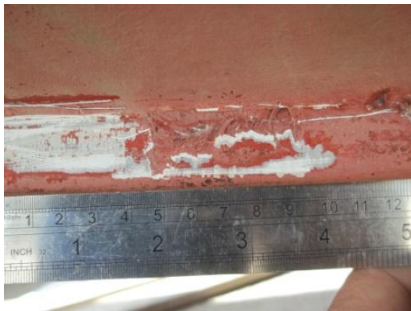
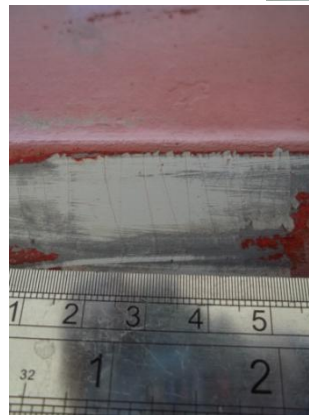
- e) The port (left side looking forward, the other side is starboard) upper spray rail in forward section has an area of stress cracking in the gel coat approximately 180mm long.

- f) Port side lower spray rail has 3 areas of gel coat missing which have been antifouled over and I suspect been in the water like this as the 1<sup>st</sup> layer of laminate is now dry (not solid with resin)

- g) Starboard side upper spray rail in a position about 1.8m forward has a gel chip.
  - h) Other than noted there are no major damage or repairs noted externally.

Spray rail damage

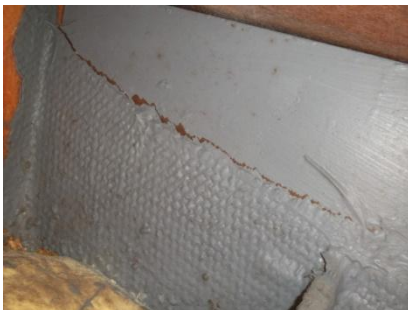
- a) The hull and deck are robustly built in the first place and has box sections bonded to it longitudinally and transversely giving added strength.
- b) The cockpit sole is laminated to the sides of the hull.
- c) All possible access was checked, lockers, under berths and the floors and inner mouldings for signs of delamination and cracks.
- d) Accessed through the port cockpit sole locker, one of the plywood floors has come debonded.

Advisory note: This area that has debonded is more to support the cockpit sole than the hull flexing and while a fairly easy repair, not structurally significant.

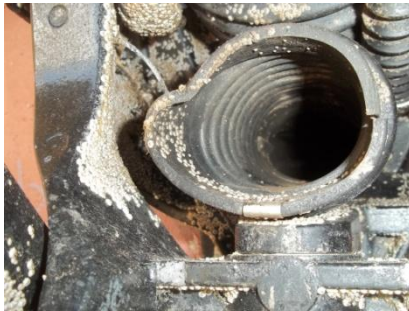
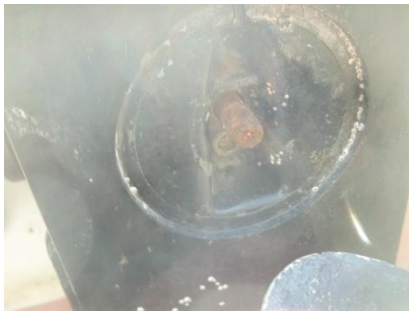
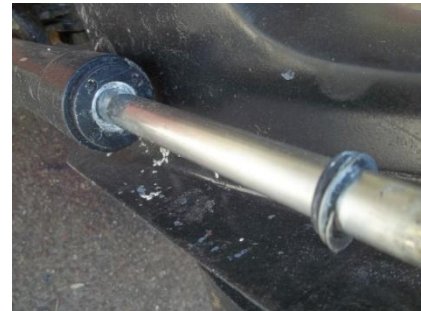
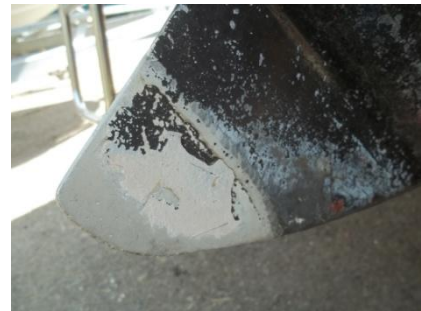
- a) The stern gear is a Mercruiser Outdrive unit Number 308349. It is fitted with a 3 Blade alloy propeller. The outdrive has marine growth on it and missing paint in sections.
- b) The outdrive was turned fully port and starboard, up and down and checked with mirrors in inaccessible places.
- c) The bottom of the drive has had a new piece welded on which causes it to angle to port slightly.
- d) The exhaust bellows were not clipped to the leg and clearly have not been for a while as there is marine growth and the end is split.
- e) The port side piston wiper has come away from its housing where it is held with a circlip.
- f) The tilt up and down trim worked as did the trailer stowage lift. The reservoir and mounting have come away from the mounting in the engine compartment.

***Recommendation: Stern drive reservoir should be correctly mounted before use. The leg should be painted with anticorrosion paint before launch.***

Recommendation: Stern drive reservoir should be correctly mounted before use. The leg should be painted with anticorrosion paint before launch.

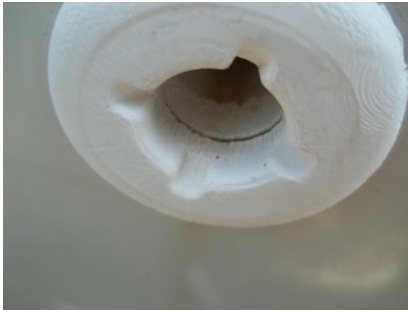
- b) Engine vents on deck moulding. Both cracked. The port one is facing forwards which will allow water to easily enter the vents. The hoses are not connected to the port vent. Both are damaged.
- c) Starboard cockpit drain – white plastic skin fitting – plastic is UV damaged and cracked.
- d) Bilge pump, starboard side upper aft, white plastic.
- e) Anchor locker drain, starboard forward, chrome.
- f) Galley drain, port side, white plastic UV damaged and cracked.
- g) Port cockpit drain – white plastic skin fitting – plastic is UV damaged and cracked.
- h) Water tank breather, chrome.
- i) Water tank filler – chrome with plastic cap.
- j) Petrol filler, Chrome with plastic cap.
- k) Petrol breather vent, chrome.

**Recommendation:-** Replace plastic skin fittings for cockpit drains x 2 and galley drain before launch. Bung in transom drain fitted before launch. Port engine vent to be turned around to face aft.

Recommendation:- Replace plastic skin fittings for cockpit drains x 2 and galley drain before launch. Bung in transom drain fitted before launch. Port engine vent to be turned around to face aft.

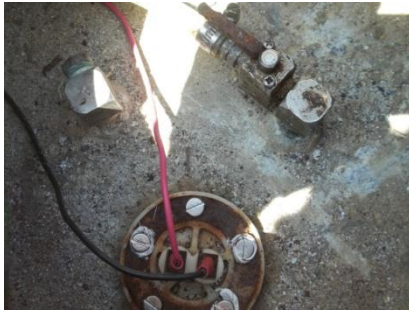
- a) Alloy tank mounted under cockpit sole, with access only through two water proof type covers. The tank is securely fitted in place with gaps around sides filled with expanding foam. Only the top surface could be checked.
- b) The top has external corrosion on it which scraped away to shiny metal.
- c) Fuel filler and breather are correct ISO 7840 marine fuel hose and securely fitted.
- d) The fuel feed pipe is braided clear hose attached to a priming pump and then outboard grade hose to the fuel filter and pump.
- e) The tank has a shut off valve located. This fitting top was loose and I suspect will leak fuel and maybe the reason for the primer bulb fitted.

**Recommendation:- Tighten or replace fuel shut off valve on tank. Replace fuel feed hose with ISO 7840 Marine grade fuel hose.**

Recommendation:- Tighten or replace fuel shut off valve on tank. Replace fuel feed hose with ISO 7840 Marine grade fuel hose.

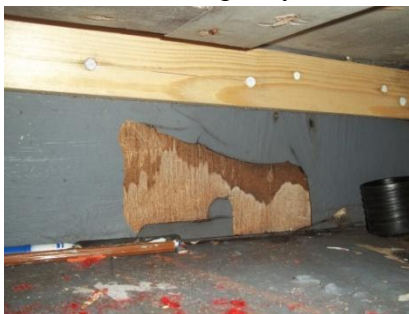
- a) The normal vinyl side lining material and cushion covers have been replaced with cloth covers and carpet.
- b) Because of this, no leaks were detected.
- c) The wood of the galley where seen in the lockers is soft and rotting. This is not structural
