# Marine Surveys UK

Survey Report no: [REDACTED]

Type of Vessel: Jeanneau Sun 2500

This survey was carried out on the [REDACTED] at Hamble Point Marina, Hamble, Southampton Hampshire UK. The above named being a prospective purchaser of the vessel.

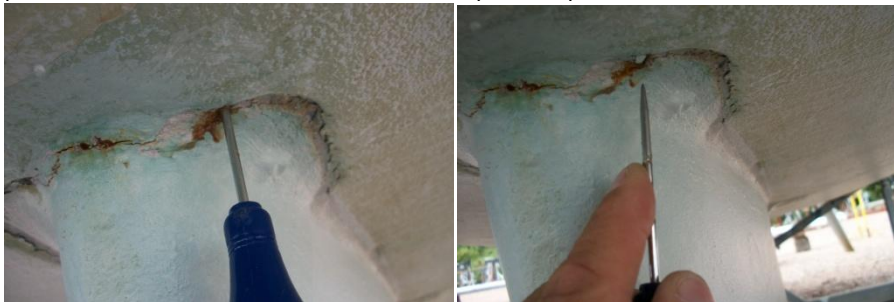
- a) The keel comprises an iron keel stub with a GRP lifting keel (centre board) internally, hinged on a stainless steel pivot with nylon bushes. It operates by halyard rope attached to a stainless steel 1x19 wire which is attached with an eye bolt into aft edge of keel. This runs up the king post through the deck to the starboard coachroof winch
- b) The keel stub has lugs cast at the top which locate into mouldings in the hull and keel bolts locate from inside the hull into these lugs to secure it to the hull. The area around these faired with a mastic / sikoflex product.
- c) At the forward end of the keel at the lug, rust or corrosion stains were noted. I was able to insert a metal spike into the mastic /sikoflex and water drops were pushed out.

Fig 1 - 2 Area at front of keel

The starboard forward lug also had signs of rust. This was scraped back and found to be surface keel rust. I suggest the mastic is removed from around the lugs, the rust cleaned off, confirm the rust is from the keel and not keel bolts. If not the keel bolts, the area should then be primed and new Sikoflex inserted and faired.

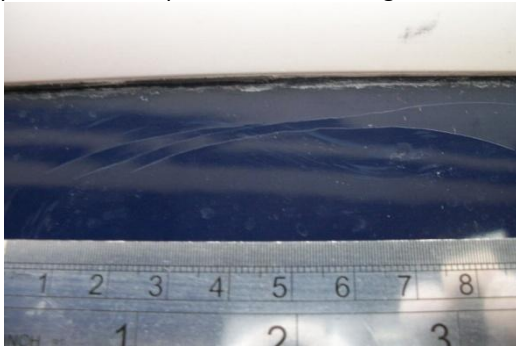
- a) Similar composition to below waterline but less layup of FRP will have been used.
- b) Top side moulding found fair and finished in the original dark blue gel coat. The gel coat surface is in generally good condition with little UV degrading. There is some abrasion noted conducive to where fenders would hang. I suggest fender socks are purchased. Exceptions noted below
- c) Gel coat crazing was noted starboard side amidships below rubbing strake approximately 70mm long and port side same position 400mm long.

Fig 3 Stress crazing starboard side.

This area could not be depressed with hammer handle and body weight. Because of their location amidships it would indicate these have been caused by minor impact possibly coming along side although protected by fenders. There will be damage to the laminate but there are no major loadings at this place. i.e rigging attachments. I suggest they should be sealed to stop water ingress, either by waxing or a better repair would be to grind back and expertly flow coat and polish however I would recommend a professional to get the correct match and finish.

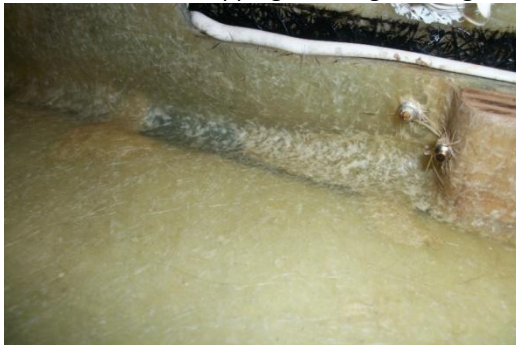
Fig 4 Underside of forward hull and deck

- b) Access is limited to the forward end of the cockpit locker, through a small hatch in the anchor locker. Inside the vessel some areas of the joint are accessible behind the material linings.
- c) Internally no signs or evidence of any leaks on linings although there is lying water in the heads under sink locker and in the bilge.

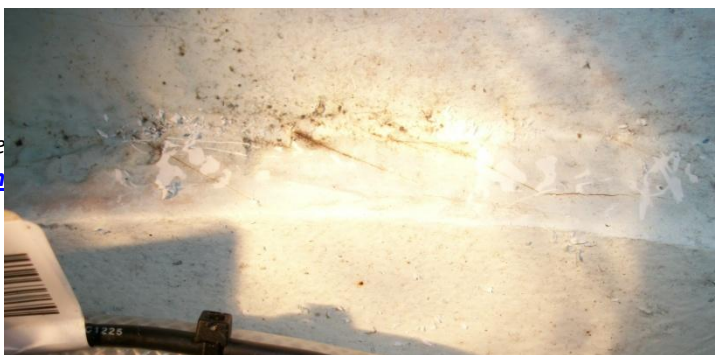
- f) At the forward edge of the forward floor bond there are 4 small hairline cracks in the bonding paste. I scraped one of these with a scraper and it disappeared. Having had the location of the forward keel bolt confirmed not to be in this area, these cracks could be caused at construction time due to excess chemical heat in the joint. There is what appears to be rust stains in the remaining cracks. There is lying water in this area, where the flexible water tank is housed and the rust could be from the clips.

*Fig 5 Cracks in forward edge of bonding of forward floor.*

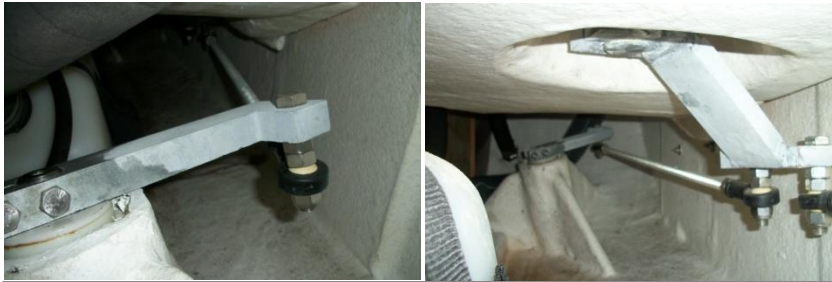
- a) Twin rudders of GRP construction made in two halves and bonded around stainless steel frames with stainless steel 316 rudder stocks. (Checked with magnet)
- b) The base of each rudder appears to have had sacrificial rubber shoes which are no longer present, only Sikoflex remains. Suggest that new shoes are purchased before beached to protect rudder bottom edge.
- c) Starboard rudder has slightly more lateral play than port rudder but not excessive.
- d) The tiller movement is a bit stiff. The rudders are linked to the tiller with mechanical universal joints. These joints are dry nylon. Suggest they are lubricated with marine grease to ease steering.

*Fig 6 – 7 Joints for steering and rudder tube*

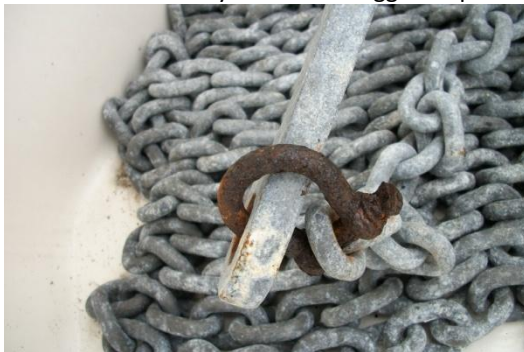
- a) Main bower anchor. This is 35kg Bruce anchor with chain and warp. Chain not laid out and examined link by link
- b) Anchor shackle badly corroded. Suggest replacement shackle and seize with wire.

Fig 8 Corroded anchor shackle

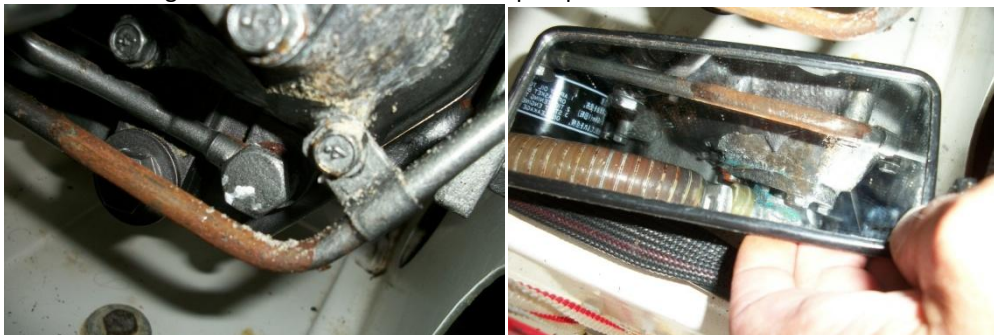
- a) Engine is generally clean, cables greased.
- b) Oil level in engine and gearbox correct.
- c) Engine is mounted on rubber mounts, tested with crow bar, good condition. No signs of corrosion and these bolted to grp engine beds, bolts all hammer tested and found secure.
- d) Evidence of long term water leak around water pump.

Fig 9 -10 Corrosion on oil pipe and cleaned underside.

This has leaked onto oil pipe below. Pipe was scraped and came clean.

Suggest remove water pump, replace all gaskets and seals in it and remove and reattach pipes. Clean and paint engine where pain removed and replace pump.

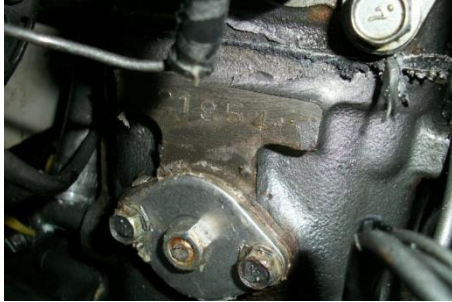
- e) Area around head gasket, paint has peeled in places. It appears to have run hot to cause this, possibly due to water leak from pump. Suggest clean up and repaint area.

Fig 11 Peeled paint around head gasket

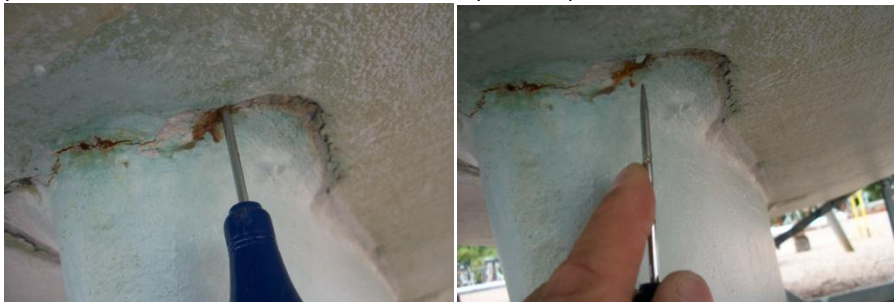
- m) The keel comprises an iron keel stub with a GRP lifting keel (centre board) internally, hinged on a stainless steel pivot with nylon bushes. It operates by halyard rope attached to a stainless steel 1x19 wire which is attached with an eye bolt into aft edge of keel. This runs up the king post through the deck to the starboard coachroof winch
- n) The keel stub has lugs cast at the top which locate into mouldings in the hull and keel bolts locate from inside the hull into these lugs to secure it to the hull. The area around these faired with a mastic / sikoflex product.
- o) At the forward end of the keel at the lug, rust or corrosion stains were noted. I was able to insert a metal spike into the mastic /sikoflex and water drops were pushed out.

*Fig 1 - 2 Area at front of keel*

The starboard forward lug also had signs of rust. This was scraped back and found to be surface keel rust. I suggest the mastic is removed from around the lugs, the rust cleaned off, confirm the rust is from the keel and not keel bolts. If not the keel bolts, the area should then be primed and new Sikoflex inserted and faired.

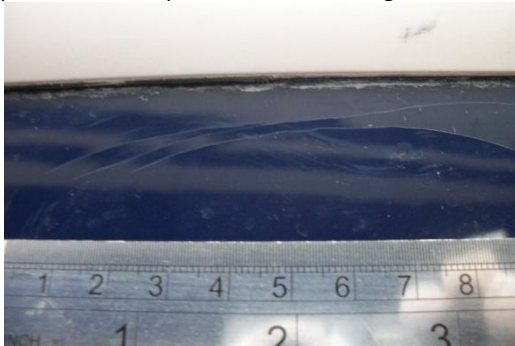
- e) Similar composition to below waterline but less layup of FRP will have been used.
- f) Top side moulding found fair and finished in the original dark blue gel coat. The gel coat surface is in generally good condition with little UV degrading. There is some abrasion noted conducive to where fenders would hang. I suggest fender socks are purchased. Exceptions noted below
- g) Gel coat crazing was noted starboard side amidships below rubbing strake approximately 70mm long and port side same position 400mm long.

Fig 3 Stress crazing starboard side.

This area could not be depressed with hammer handle and body weight. Because of their location amidships it would indicate these have been caused by minor impact possibly coming along side although protected by fenders. There will be damage to the laminate but there are no major loadings at this place. i.e rigging attachments. I suggest they should be sealed to stop water ingress, either by waxing or a better repair would be to grind back and expertly flow coat and polish however I would recommend a professional to get the correct match and finish.

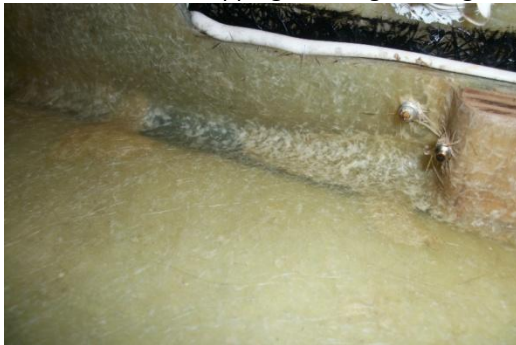
Fig 4 Underside of forward hull and deck

- e) Access is limited to the forward end of the cockpit locker, through a small hatch in the anchor locker. Inside the vessel some areas of the joint are accessible behind the material linings.
- f) Internally no signs or evidence of any leaks on linings although there is lying water in the heads under sink locker and in the bilge.

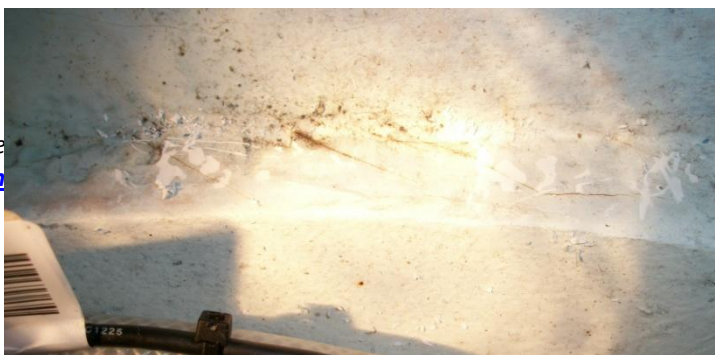
- l) At the forward edge of the forward floor bond there are 4 small hairline cracks in the bonding paste. I scraped one of these with a scraper and it disappeared. Having had the location of the forward keel bolt confirmed not to be in this area, these cracks could be caused at construction time due to excess chemical heat in the joint. There is what appears to be rust stains in the remaining cracks. There is lying water in this area, where the flexible water tank is housed and the rust could be from the clips.

*Fig 5 Cracks in forward edge of bonding of forward floor.*

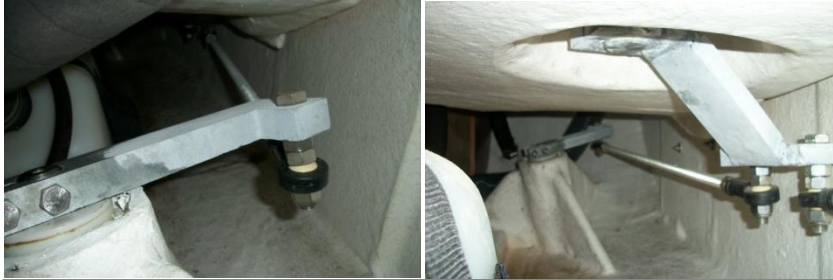
- h) Twin rudders of GRP construction made in two halves and bonded around stainless steel frames with stainless steel 316 rudder stocks. (Checked with magnet)
- i) The base of each rudder appears to have had sacrificial rubber shoes which are no longer present, only Sikoflex remains. Suggest that new shoes are purchased before beached to protect rudder bottom edge.
- j) Starboard rudder has slightly more lateral play than port rudder but not excessive.
- k) The tiller movement is a bit stiff. The rudders are linked to the tiller with mechanical universal joints. These joints are dry nylon. Suggest they are lubricated with marine grease to ease steering.

*Fig 6 – 7 Joints for steering and rudder tube*

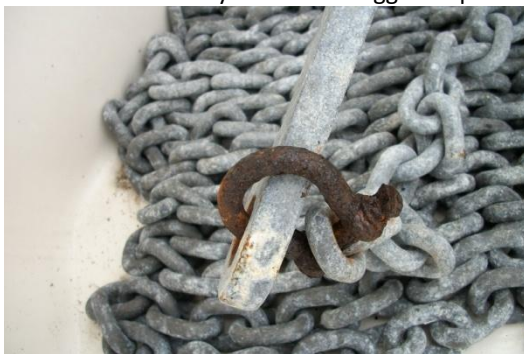
- f) Main bower anchor. This is 35kg Bruce anchor with chain and warp. Chain not laid out and examined link by link
- g) Anchor shackle badly corroded. Suggest replacement shackle and seize with wire.

Fig 8 Corroded anchor shackle

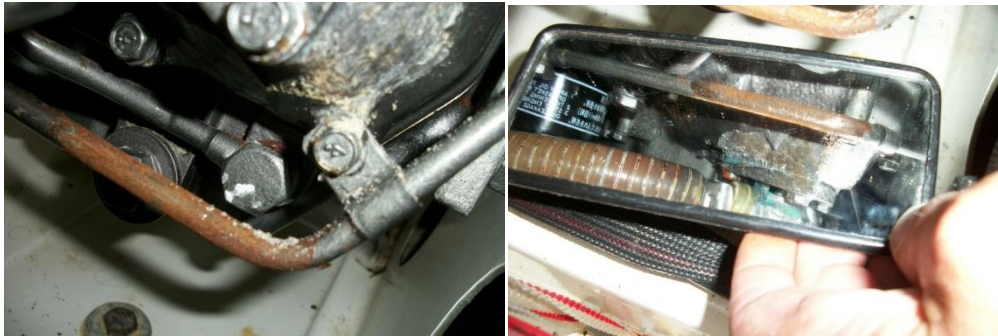
- i) Engine is generally clean, cables greased.
- j) Oil level in engine and gearbox correct.
- k) Engine is mounted on rubber mounts, tested with crow bar, good condition. No signs of corrosion and these bolted to grp engine beds, bolts all hammer tested and found secure.
- l) Evidence of long term water leak around water pump.

Fig 9 -10 Corrosion on oil pipe and cleaned underside.

Suggest remove water pump, replace all gaskets and seals in it and remove and reattach pipes. Clean and paint engine where pain removed and replace pump.

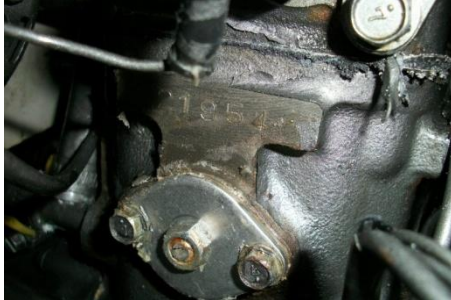
- m) Area around head gasket, paint has peeled in places. It appears to have run hot to cause this, possibly due to water leak from pump. Suggest clean up and repaint area.

Fig 11 Peeled paint around head gasket
