Survey Report no: [REDACTED]

Type of Vessel: Hanse 315, 2006, FRP (Fibre reinforced Plastic), mono hull, Bermudian sloop rigged sailing vessel

Type of survey: Pre-purchase

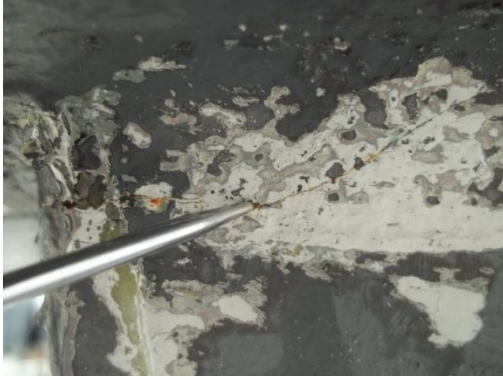
- c) There was a fine hairline crack in the FRP at the aft end of the keel stub approximately 70mm long.

Advisory Note: The Hanse agent advised that the keel is attached to an FRP stub which then has a galvanised frame in the hull and stainless keel studs and nuts hold the keel through this. He is not aware of any issues in the 5 years he has been at Hanse with these keel fixings. I suggest the cabin sole boards are removed to have a look at the keel bolt fixings just to make sure there are no signs of movement internally and if there are none, then next time the boat is hauled, grind out and fill crack with epoxy filler.

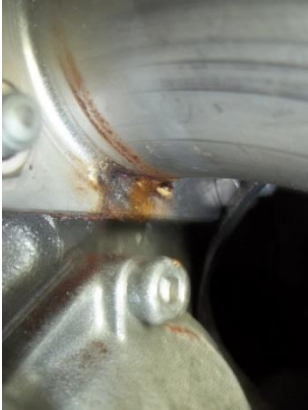
- f) The exhaust hose is well clips and goes to a plastic water trap and then in a loop to the deck and out of the hull as described above.
- g) There is a small hole in the weld the exhaust elbow. This is leaking water on to the engine below and will get worse if left.

Exhaust leak.

Recommendation: the exhaust elbow should be removed and replaced or welded.

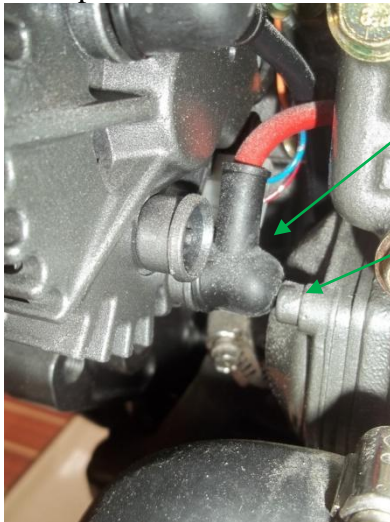
- h) The alternator positive wire terminal although rubber covered is very close to the engine block, this is the design and therefore as long as the alternator remains tight there should be no problem.

Positive lead

Engine case
