Survey Report no: [REDACTED]

Type of Vessel: Fairline Targa 44, FRP Motor vessel

Type of survey: Pre-purchase

This survey was carried out on [REDACTED] ashore at Hamble River Boatyard, Bridge Road, Swanwick, Southampton, SO31 7EB, UK. The above named being a prospective purchaser of the vessel.

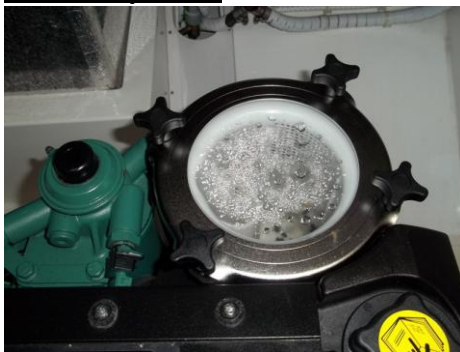
- Purchaser advised during sea trial starboard seawater strainer top came off and flooded engine bay. Broker advised engine bay has been cleaned and engine sprayed with lubricant. This has been done. Broker advised seawater strainer tops have been replaced with bolt down type. This is confirmed. The starboard engine port forward mount is slightly corroded. It is possible the starboard strainer has leaked before.

New cover to strainer
