Marine Surveys UK

Survey Report no: [REDACTED]

Type of Vessel: Dehler 34, FRP (Fibre reinforced plastic), Bermudian sloop sailing boat.

Type of survey: Pre-purchase and valuation

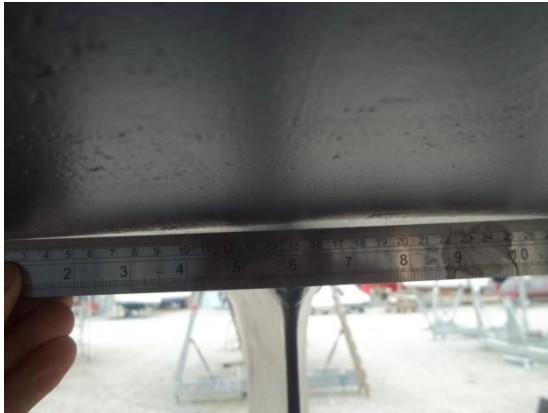
- g) There was no signs of cracking or debonding in the boat aft of the keel that I was able to see, although the sole boards are screwed down and give limited access.

Hogging aft of the keel

Advisory note: It is not unusual for FRP boats to be affected by hogging (deflect inwards) slightly when sat on their keel as they are not designed for this.

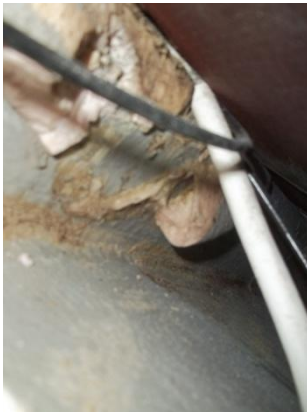
Floor under kingpost

Recommendation: The cabin sole should be lifted to check the base of the king post where it sits on the floors. This may be over zealous filling but it is out of character to the rest of the smooth bilge.

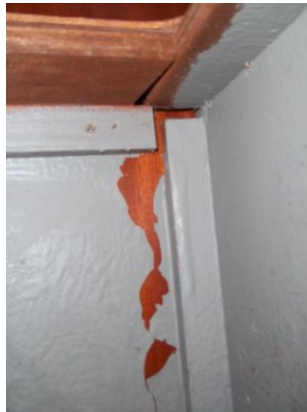
- f) The port side saloon berth front furniture (plywood) has moved from the aft of the forward bulkhead, evidenced by flow coat cracking. This is not a structural point.

Furniture shift

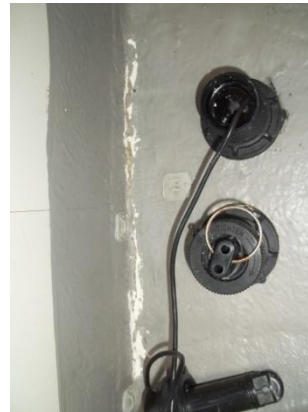
Advisory note: There has been some movement of forward bulkhead at its lowest point but the sides are still bonded as far as I can ascertain.

Delaminated bulkhead

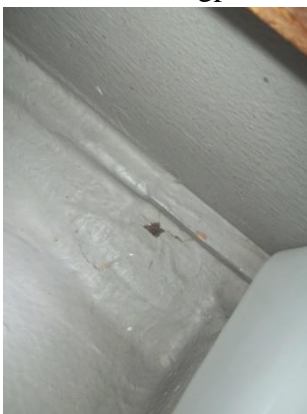
- h) The port forward locker has broken flow coat, this is more of an impact. If I had seen this when the boat was out of the water I would have wanted to check the hull for stress cracks in the same place. There are no signs of leaks.

Locker

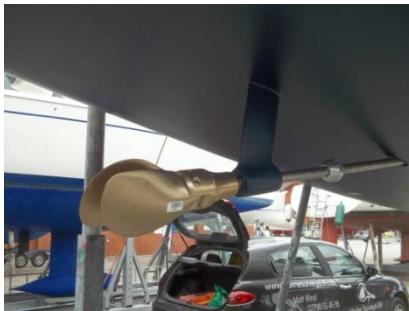
- a) There is no hull anode as designed and one shaft anode. A new anode has been fitted, which in my view is too small for the propeller size, especially in Sovereign harbour which is known to have high electrolysis problems. The recommended conservative size of anodes for a boat this size is 3.6lbs. The boat also has a drop over the side anode which is wasted (heavily worn).
- b) There is a galvanic isolator fitted in the shore power circuit to protect the boat a little more when on shore power.

Advisory note: Replace drop over side anode and ensure it is used when ever in harbour.

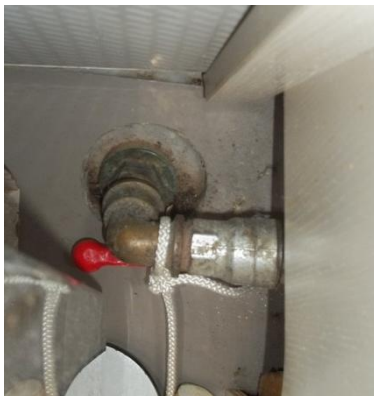
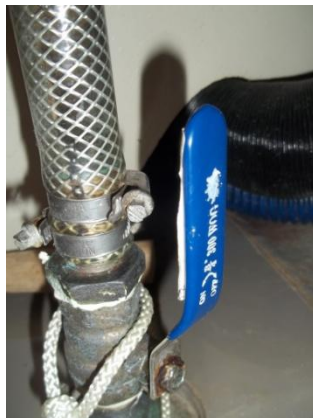
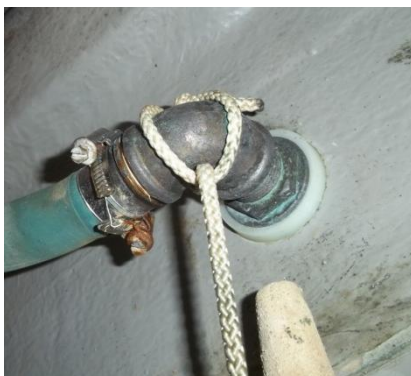
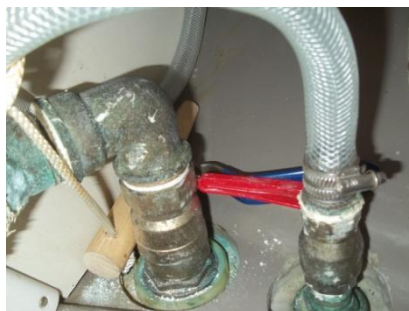
Clockwise from left – Galley, Heads, holding tank breather, toilets.

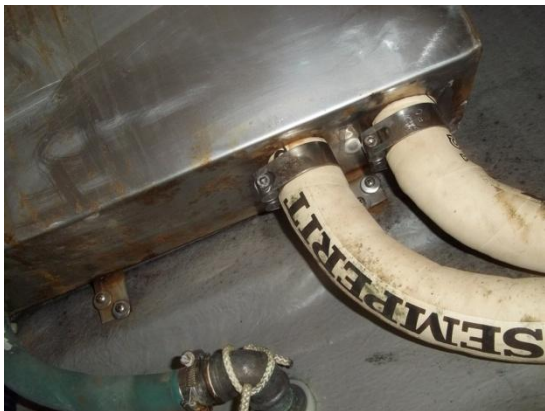
- a) Toilet is manual Jabsco sea water flush. Waste pumps directly to stainless steel holding tank mounted behind heads furniture. Tank empties by gravity through skin fitting described in section 13 above. Tank has breather / overflow on water line. Diameter 18mm.
- b) The clips on the hoses were found tight. The hose from the holding tank to the outlet skin fitting is a bit stained. There are mild corrosion stains running from the top of the tank which is out of view and mild corrosion stains around the breather.

Holding tank stains

Advisory note: It is my view that the tank will have an inspection hatch on the top with a gasket and that this has leaked or is leaking when the tank is full. The holding tank breather / overflow is smaller diameter than the exit. This means that if the tank is over filled the breather will not cope well and the tank will pressurise. Comments on the internet at www.dehlerowners.co.uk suggest leaking holding tanks is a common issue and they are hard to remove. (Plus they are a heavy item to carry around on a race boat with many plastic alternatives available).

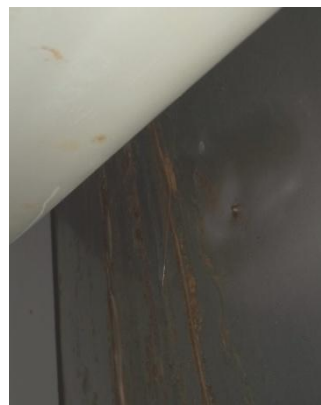
Stains from top of tank
