Survey Report no: [REDACTED]

Type of Vessel: 2006 Model, Nimbus 280 Coupe,
Motorboat, FRP (Fibre Reinforced Plastic)
construction, semi displacement hull.

Type of survey: Pre-purchase survey

This survey was carried out on the [REDACTED] at Yacht Haven
Lyminster, SO41 3QD on the hard. The above named being a
prospective purchaser of the vessel.

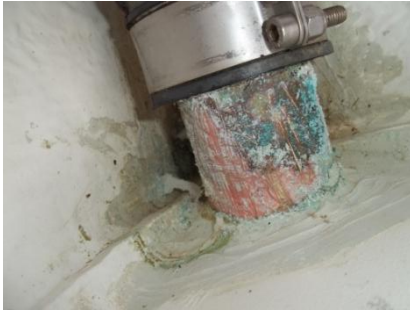
- c) The shaft was free to turn and no signs of distortion noted.
- d) At the inboard end of the stern tube, the bronze stern tube has signs of dezincification and there are signs of water under the gland. The tube was scraped to shiny metal just below. There appears to be some Sikaflex or bonding paste applied around the tube.

Stern tube inboard end

Advisory Note: The broker advised that the stern tube condition is normal on the Nimbus, the gland has to be squeezed to expel air when the boat is launched and the water is never mopped up. I noted that the sterntube is not connected to the hull anode, again the broker advised this is normal. I advise when the boat is launched, once the gland has been squeezed, mop up any water and monitor if any water enters via the outside of the tube. If not, keep this area dry.

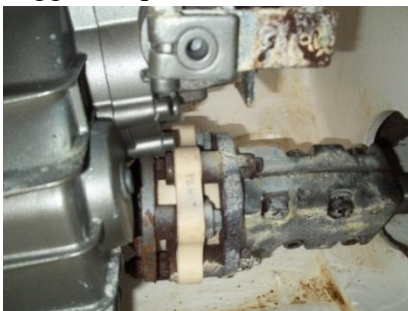
- a) The boat is fitted with a single Volvo Penta Diesel engine type D3-160. Engine number 2003003807. Broker advises hours to be 170 hours
- b) I did not have keys for the engine system so could not check gauges or hours. The engine has been laid up with belts removed, exhausts removed and blocked, water drained, vulnerable parts greased.
- c) The engine compartment is generally clean, as is the engine. There were no signs of water, oil or diesel leaks.
- d) The engine service book was aboard and showed regular servicing, the last being 16/7/2009 at 144 hours.
- e) The engine is mounted on rubber mounts, these were tested with a crow bar and found secure.
- f) The Morse control (forward and astern and speed) operated smoothly
- g) There is some minor corrosion around the aft end of the engine and coupling.

Advisory note: The purchaser has advised the engines will be serviced when commissioned. Suggest request corrosion is removed and parts painted to prevent further.

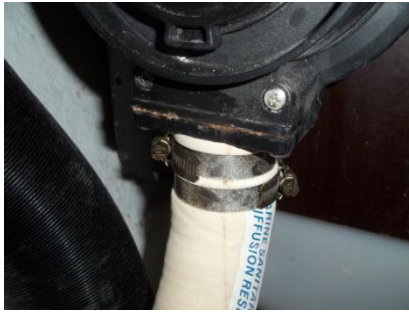
- a) Toilet is Jabsco Manual operated Seawater flush. Inlet pipe goes direct to toilet, no swan neck. Toile toutlet connects direct to plastic holding tank. This has a vent overboard. The outlet connects to pump out pump and the hose from here is to sea direct or to deck pump out. Slight leak at base of pump.

Minor leak at holding tank pump.
