Marine Surveys UK

Survey Report no: [REDACTED]

Type of Vessel: 35' Cutter rigged Sloop sailing vessel constructed of plywood over wooden frames and stringers with double chine. Stated 1988.

This survey was carried out at The Ship Yard, Rope Walk, Littlehampton, West Sussex, BN17 5DE on the [REDACTED] The above named being the owner of the vessel.

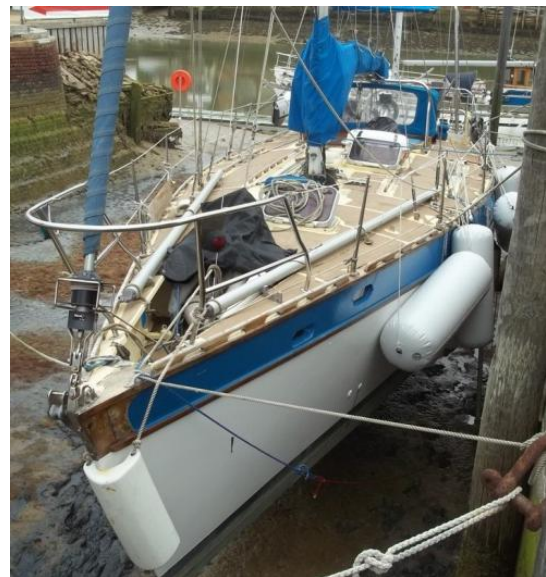
Eldro has plywood hull over timber frames and stringers (wood frame), the underwater section of hull and keel have fibreglass laminated over them. She is built with double chines (for ease of home build) and a plywood deck. The equipment is of good quality. There is very little technical information available about the boat on the web. There is a builders plate attached to the bulkhead stating she was built by a [REDACTED] and the model is stated as All Straight built 1988. It was last sold as a “1984 Hartley style”, presumably referring to Richard Hartley a New Zealand designer of wooden boats although I cannot find a similar one.
