Survey Report no: [REDACTED]

Name of Vessel: "not named"

Type of Vessel: 16' open sailing boat, with inboard engine, wood construction clinker type.

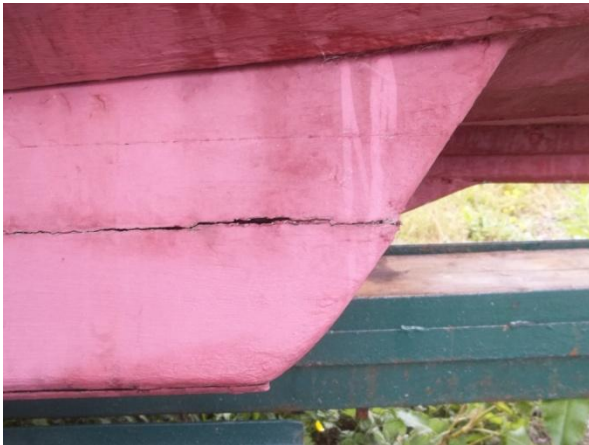
The starboard bilge plate is separating at the front between the first and second laminate. This is not structural but is in danger of coming away.

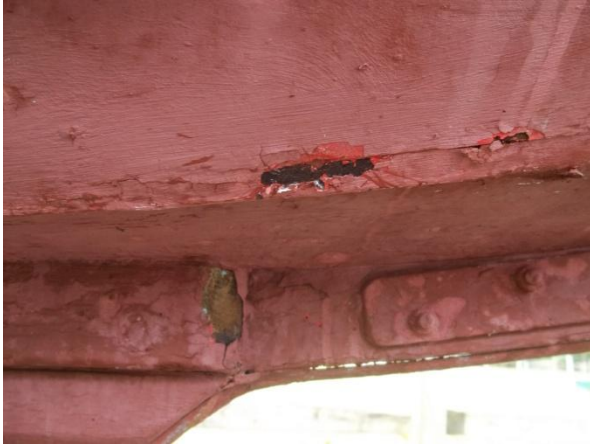
The hull below the water line has been partially sheaved with Glass fibre tape and matting. This is not consistently over the hull and appears to have been done to try to stop leaks. Likewise some of the joints have an excess of silicon applied to prevent leaks. This Glass fibre tape is not well bonded in many places and easily broke away when tested. Where I was able to test the wood planking below, although dark in colour, it was found firm.

Water is dripping from the front section of planking joints from under the sheaving.

Recommendation: *It is clear that a number of leaks have been attempted to be stemmed and that the vessel is hogging on its cradle. The repairs are either not professionally made (inboard single strip glass fibre tape or are failing. I have no history of when the repairs were made, whether they have been since the boat has been shore or before. Ideally the bottom of the boat should have all sheaving and filling removed, a good auto bilge pump fitted and be put in seawater to see if the planks will take up and seal naturally. If they do, then a decent coating of primer and antifouling paint should be sufficient. If they do not, then the bottom probably needs to be fully sheaved in FRP to extend her life or taken apart and rebuilt.*

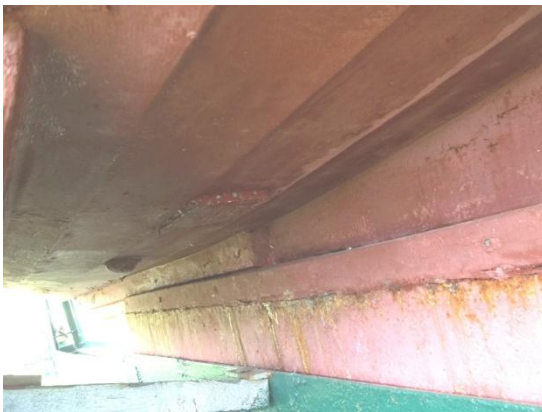
On the 2nd plank out from the keel both sides a square sided double plate of unknown material has been fitted and coated in antifouling. The edges have not been tapered.

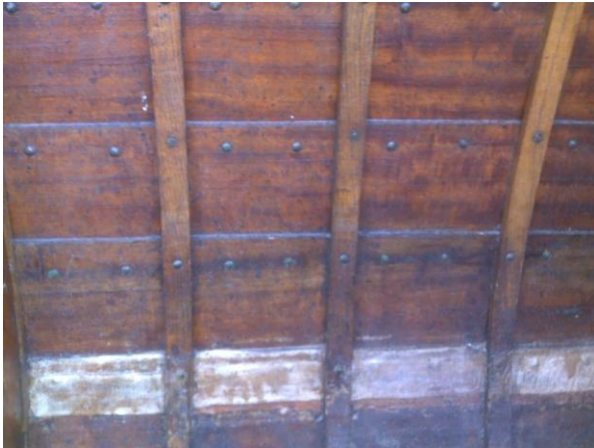
Inboard at the water line starboard side a single strip of GRP tape has been applied, it has not been fully wetted and from what I can ascertain could be covering a split caused by the hogging.

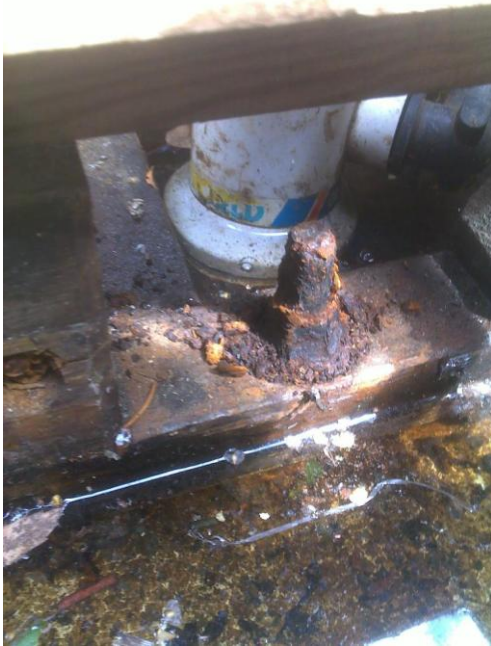
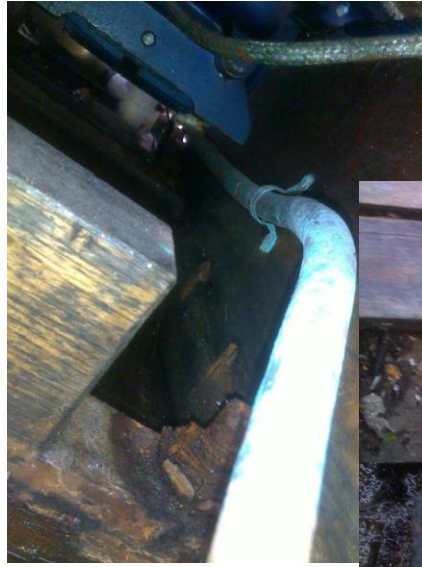
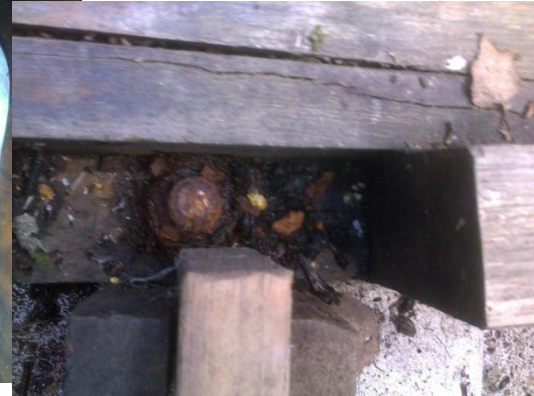
The studs and nuts holding the iron/steel ballast were tested with a hammer and the 2nd from aft and 3rd from aft the nuts disintegrated as did the threads of the studs.

Recommendation: The ballast keel should be dropped and all studs checked and replaced as necessary before use.

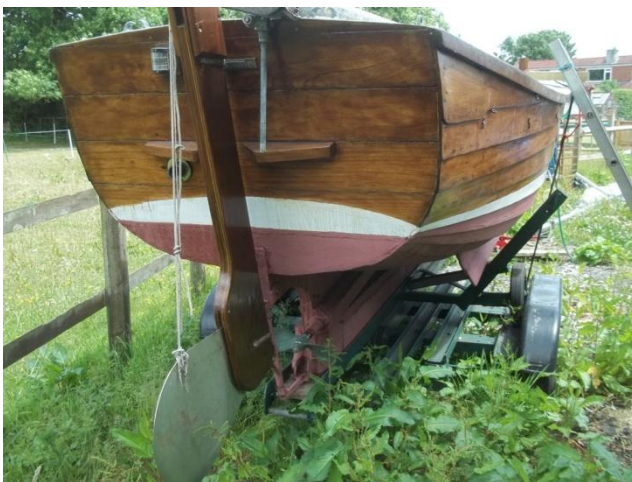
The transom planks are separating at their joints above the water line. As these are butt joints, they can be glued together.
