## Marine Surveys UK

Survey Report no: [REDACTED]

Type of Vessel: Dufour 36 Classic, FRP Bermudian sloop sailing vessel

Type of survey: Pre-purchase

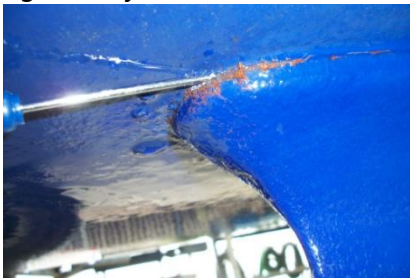
*Fig 1 keel joint*

- c) The keel was lying fair to the hull, there was corrosion stains around the aft end of the keel to hull joint. The vessel was hanging in its slings. I was able to “squeeze” the joint by lifting the aft end of the keel and water came out. I could insert a metal spike only 1mm into the joint. It is often the case with mass produced boats that the keel is not exactly shaped to the hull at the aft end and I have often seen gaps here. See fig 1

The deep mode reading of 26 was immediately aft of the keel and could be attributed to the loose keel and water entering the FRP around the stud.

***Recommendation – The aft keel studs should be accessed and then tightened to correct torque. When the boat is next ashore, slacken the aft keel stud, dry the area and apply Sikaflex 291 sealant to prevent further water ingress.***
