## Marine Surveys UK

Name of Vessel: "[REDACTED]"

Type of Vessel: Etap 21i, FRP (Fibre reinforced Plastic), Bermudian sloop fractional rig with outboard motor.

Type of survey: Pre-purchase

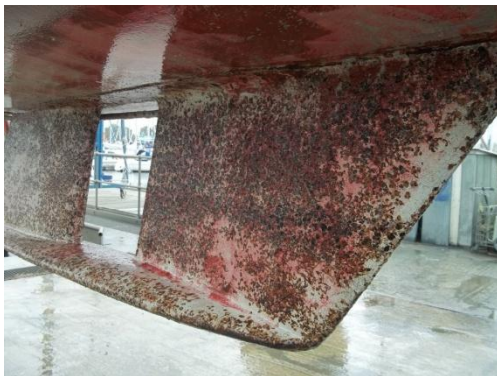
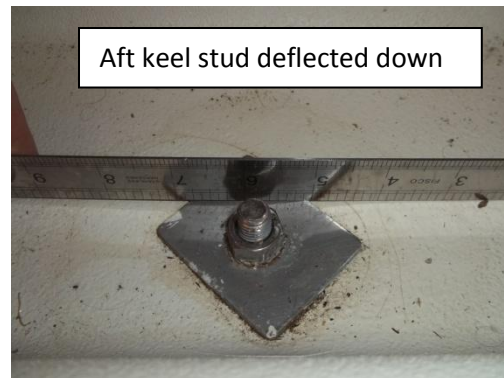
- a) The keel is of iron, in tandem style. It is attached to the hull with stainless steel studs. Inside the hull are stainless steel plates and nuts. There is a stud forward and aft and 2 groups of 3 studs. 8 in total.
- b) The keel surface is covered in pitting through the paint. It scrapes off easily to a shiny surface. This is caused by electrolyse from stray currents in the marina and the paint breaking down on the keel.
- c) The joint of keel to hull is filled with sealant and at the back edge it appears to have been further filled. This was checked with a spike and at the back edge, the spike went behind the sealant.

- d) Inboard the vessel, the aft keel nut and plate has compressed the inner moulding by approximately 2mm across a section of 150mm. The inner liner has stress cracks at this point.
- e) The forward keel nut has mild corrosion on it and does one of the second set forward. This is clearly visible under the cabin sole boards.
- f) There is no water in the bilge of the boat when it was afloat and no signs it has been dried out recently.
- g) I saw the keel hanging in the slings and then lowered it onto wooden blocks. During this process the hull and keel joint moved at the aft end some 5mm and black water squeezed out.

***Recommendation:- The hull keel attachment is not as secure as it should be. Coupled with the moisture reported in the hull below, I recommend that the keel be dropped, the threads of the studs checked. The hull checked around the stud holes. If all is found sound or after repairs made, the keel reseated with Sikaflex 216 or similar joint compound and the nuts tightened to correct torque. This is to stop water creeping up the threads and causing corrosion and possibly entering the sandwich section although the area around the keel bolts should be solid FRP. The outside surface of the keel should be cleaned up to bare metal, the keel primer with suitable iron primer and antifouling paint applied.***

Recommendation:- The hull keel attachment is not as secure as it should be. Coupled with the moisture reported in the hull below, I recommend that the keel be dropped, the threads of the studs checked. The hull checked around the stud holes. If all is found sound or after repairs made, the keel reseated with Sikaflex 216 or similar joint compound and the nuts tightened to correct torque. This is to stop water creeping up the threads and causing corrosion and possibly entering the sandwich section although the area around the keel bolts should be solid FRP. The outside surface of the keel should be cleaned up to bare metal, the keel primer with suitable iron primer and antifouling paint applied.

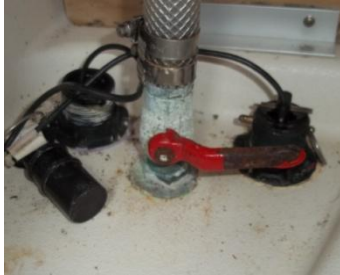
- a) Galley sink drain, located under galley. Yellow metal skin fitting with silver coloured ball valve and yellow metal spigot. 2 hose clips. The valve and skin fitting inboard have surface corrosion.
- b) Log and depth fittings, both plastic through hulls.

**Advisory note:** Although the fitting passes the tests above and the outside scraped to clean metal, for the relatively low cost, I suggest that the ball valve is removed and cleaned and replaced if required.
