Survey Report no: [REDACTED]

Type of Vessel: Monterey 355 SY, FRP (fibre reinforced plastic) constructed, Deep V hull shape, twin diesel engine, motorboat.

Type of survey: Pre-purchase

This survey was carried out on [REDACTED] at Port Hamble Marina, Hamble, Hampshire on the hard standing area. The above named being a prospective purchaser of the vessel.

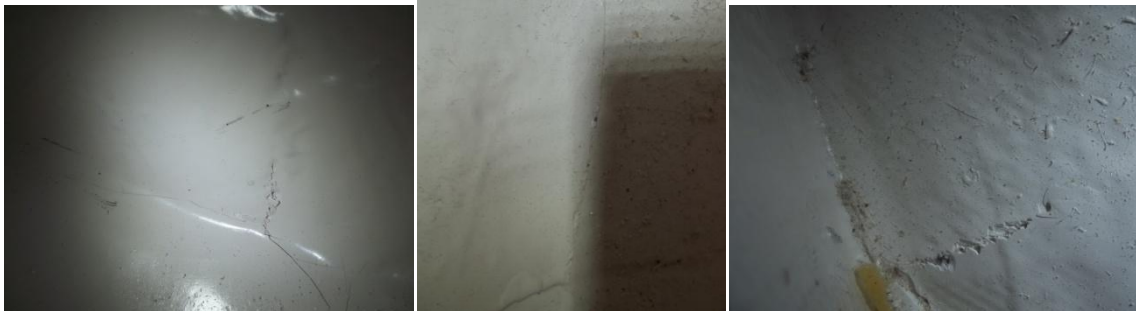
- a) The hull and deck mouldings are robust in the first place. And inner liner forms the cabin sole and furniture bases. This is delaminating to the hull.
- b) All possible access was checked, lockers, under berths and the floors and inner mouldings for signs of delamination and cracks.
- c) As noted in section 2 above, accessed from the aft locker below the main berth to the port side, there is signs of minor cracks of the bonding.

Note these cracks are only 25mm long

Advisory note: For cosmetics sake, the anchor locker bulkhead could be painted with a gelcoat paint. Likewise the inner hull section, or in this area FRP lamination could be applied for further strengthening.

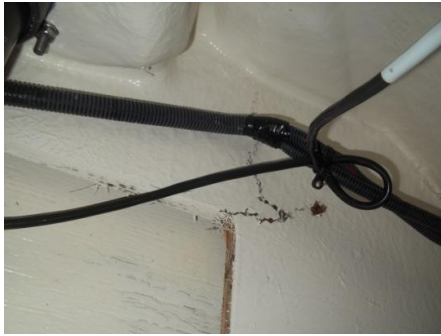
- d) In the anchor locker the small bulkhead / stiffening mounted aft of the windlass, the port corner upper corner has cracked. This is more cosmetic than structural as there is still plenty of other support in this area.

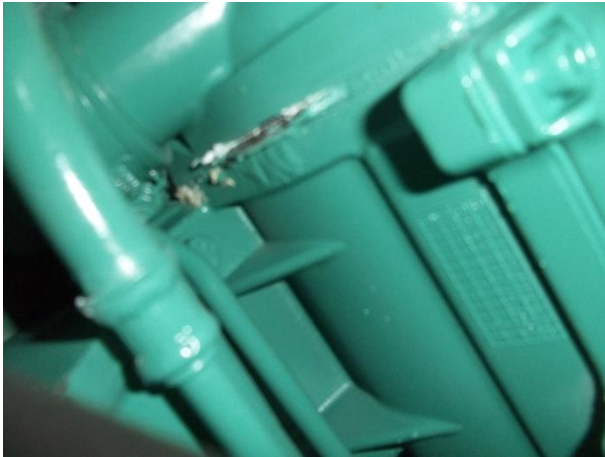
- f) Both Intercooler units – part of the air intake system with sea water running through to cool the air – have minor corrosion at the base of the forward gaskets. This indicates that they are starting to scale up.

Leak under intercooler gasket

Advisory note: The intercoolers should be descaled at the next service.
