Marine Surveys UK

Survey Report no: [REDACTED]

Type of Vessel: Beneteau Antares 650HB, FRP Motor vessel

Type of survey: Pre-purchase

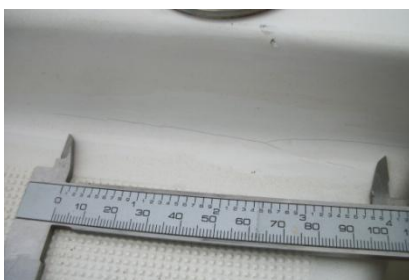
- a) Topsides have a single chine, constructed of solid FRP.
- b) Top side moulding found fair and finished in white gel coat. Minor abrasions noted, no signs of damage or repairs except where noted below.
- c) No stress crazing or cracking noted in way of bulkheads or other re-enforcing members
- d) A white rubber rubbing strake runs around the hull and deck join.
- a) There were two areas of minor stress cracks Starboard side, just above rubbing strake at front of wooden capping. 50mm long. And Starboard side transom edge. Also 50mm. See picture at end of document.

Star crack

Advisory note:- These areas could not be flexed when pressed or pulled. They are possibly from settling or minor impact. Star cracks in the gel coat, if not repaired should be heavily waxed to prevent water ingress into the laminates.

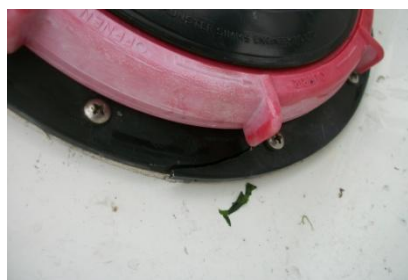
- a) Windscreen wiper blade split.
- b) Transom watertight locker lid TCL/4 housing is split. See photo.

Watertight lid crack

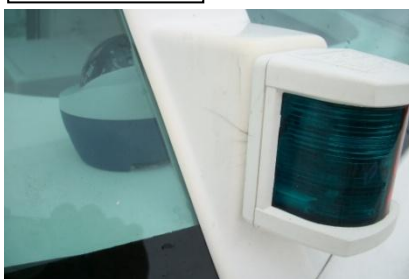
- b) Deckhouse. 2 x side opening windows.
- c) Main screen. Plastic frames so no signs corrosion. There is slight split in frame starboard side bottom and behind the navigation light. These do not appear to be leaking. See picture at end of document.

Crack on screen pillar
