Survey Report no: [REDACTED]

Name of Vessel: "[REDACTED]"

Type of Vessel: Jeanneau Prestige 36, FRP Motor vessel

Type of survey: Pre-purchase

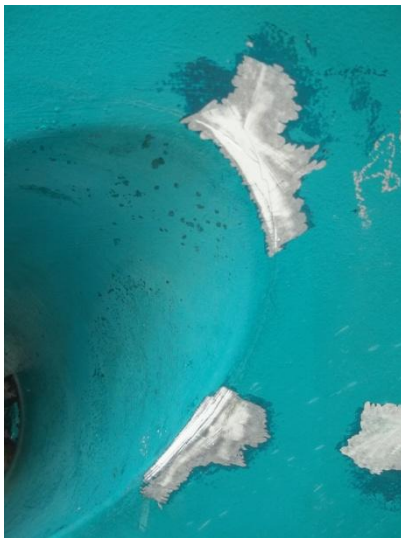
**Bow thruster**

- f) The antifouling was removed to the white gel in 60 patches approximately 50mm x 50mm at random around the hull and transom below the water line. While scraping I was looking for signs of moisture ingress like wicking or blisters. None were found.
- g) The chines and spray rails were checked under 10 x magnifications for signs of stress cracking. None were noted.
- h) There are no signs of major damage or repairs to the hull.
- i) There are cracks in the gel coat around the port side of the bow thruster. This is a common problem with these boats. Internally there are no cracks.

Meter	Range below waterline.	Range above waterline.
Sovereign Quantum, Scale 0-100 Shallow mode	<b>13 – 15 with 18 on bow thruster cracks</b>	<b>11</b>
Deep Mode	<b>11 - 16</b>	<b>11</b>

**Advisory note:** The cracks should be cleaned and filled with epoxy to prevent water ingress into the fibre laminate below.

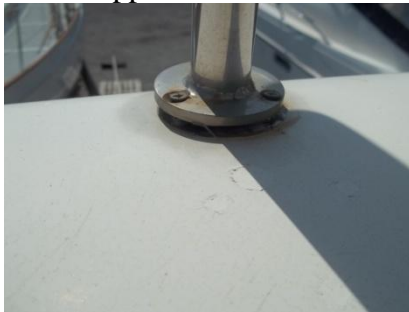
- a) Radar support on radar arch. Stainless steel. Fixing is loose.

**Advisory note-** Fixing should be secured to prevent losing radar.
