Marine Surveys UK

Survey Report no: [REDACTED]

Name of Vessel: "Unnamed"

Type of Vessel: *American* Hunter 22, FRP (Fibre Reinforced Plastic) Bermudian Sloop rigged, lifting keel trailer sailor.

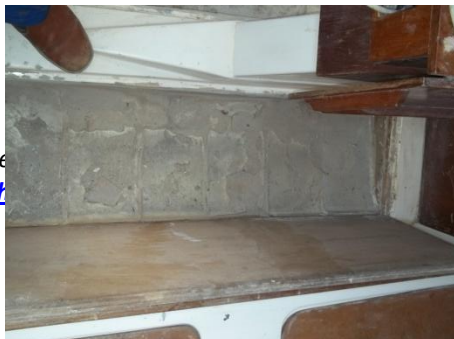
- g) Under the cabin sole boards, there is evidence that some structure has been cut away. Not knowing this boat design, unless the owner can shed a different light, research on the web indicates that the boat should have some 1400lbs of lead ballast of which 1250lbs is ballasted in the hull. Is this area where the lead was bonded and has it been removed?

Lead ballast – in the absence of detailed drawings or evidence to contrary from the owner 1250lb of ballast ingots will need to be fitted under cabin sole boards.

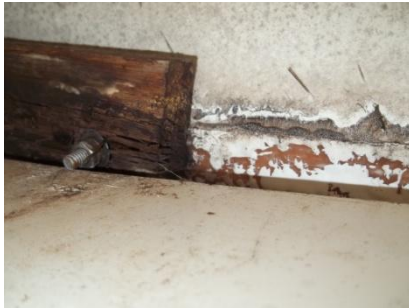
- a) Stainless steel pulpit and push pit with single stainless steel 1 x19 wire guard rail.
- b) Port forward guard wire fixing is mild steel split ring.
- c) Pushpit mounting is loose. Strengthening plates below deck is wood which has rotted.

Pushpit backing wood

Recommendation: If pushpit is fitted, replace backing plates with marine plywood and large stainless steel washers
