Marine Surveys UK

Survey Report no: [REDACTED]

Name of Vessel: "[REDACTED]"

Type of Vessel: Carver Montego 27, FRP (Fibre reinforced plastic) constructed, twin petrol engine, fast semi displacement hull, motor vessel.

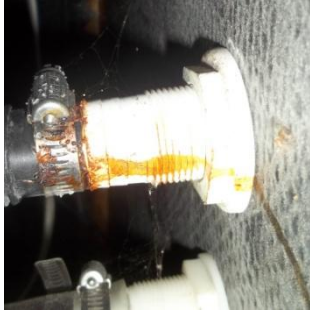
Forward bilge pump outlet leaking.

- a) 1500GPH Electric bilge pump with auto float switch in engine compartment, and manual operation at helm station - works and exits port aft as noted above.
- b) 1500GPH Electric bilge pump with auto float switch in forward saloon area and manual operation at helm station - works and exits port midships as noted above – see recommendation.

Recommendation: Ensure toilet outlet valve is free to close and fix leak on forward bilge pump outlet hose.

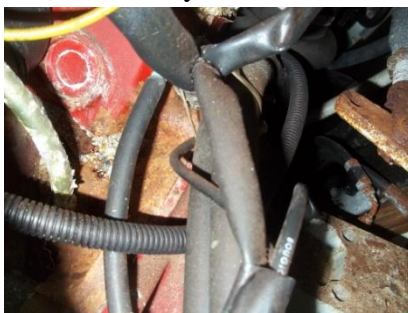
- a) The boat is fitted with twin Volvo Penta AQ171C 4 Cylinder petrol engines.
- b) Numbers were not easily visible. Engine hours stated 646 on gauge.
- c) The engine room is vented naturally with fan blowers in the extraction side.
- d) The engines are rubber mounted, bolted to the FRP bearers. These were struck and solid.
- e) The port engine has a lot of corrosion on the port side. This has caused the alternator to seize and the belt is snapped. On close inspection with mirrors and camera, as far as I can ascertain the cylinder head core plugs are leaking in particular the aft one port.

Leaking core plug

Recommendation: Free up alternator and fit new belt. Replace core plugs on port engine - it is possible to change with out removing cylinder heads I believe. Replace copper pipe in water inlet starboard engine. Replace port distributor cap. Replace starboard header tank cap.

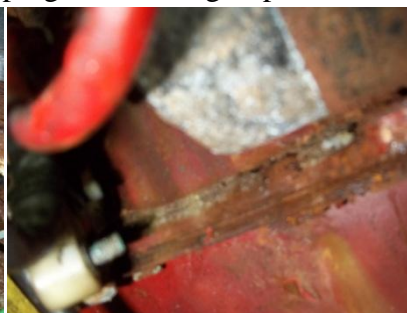
Corrosion on block and alternator

Advisory note: The above recommendations are to get the engines going and fix faults identified at this time. Once work has been carried out, I suggest cleaning the engines down and the engine bilges, run the engines off a water supply and check for any oil or water leaks. Once this done, then invest in a service unless invoices show it is not due and finally repaint engines and all corrosion areas to prevent further corrosion.

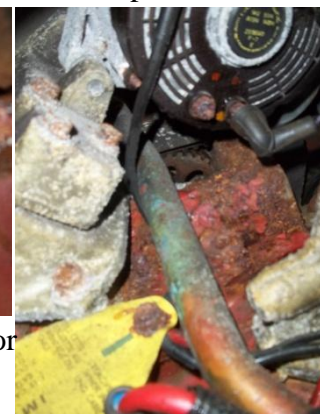
- f) On the centre picture there appears to be a nut missing from a bracket on the port engine.
- g) In the starboard engine water intake from the stern drive, there is a copper fitting which has two pipes leaving it. This is dezincifying and going soft.

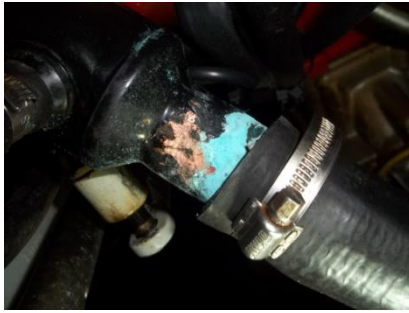
Sea water take off.
