Marine Surveys UK

Survey Report no: [REDACTED]

Type of Vessel: Moody 31 MK11

This survey was carried out on the [REDACTED] at Elephant Boat yard, Lands End Road, Old Bursledon, Hampshire SO31 8DN, UK. The above named being a prospective purchaser of the vessel.

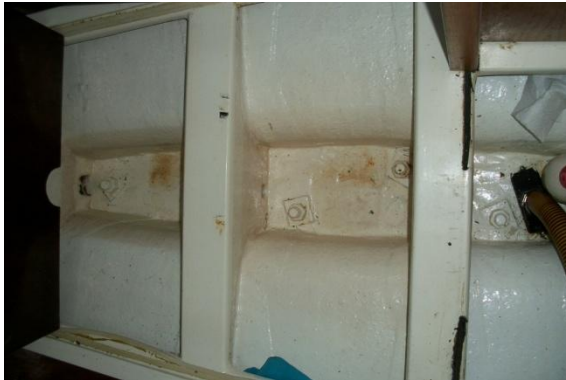
- d) The keel studs and nuts have been coated in white flow coat or paint. I was able to view all except one which is below the forward cabin sole which is screwed down. The studs and nuts are non magnetic indicating good stainless steel. They were all struck with a hammer and found sound. The aft nut in second bilge has signs of corrosion stains coming from under the paint. If stainless steel is starved of oxygen it can corrode or this could be the mild steel plate rusting. *Suggestion – when convenient, clean off the paint, check the condition of the studs and nuts and keep clean. The mild steel plate should be painted with red oxide primer but keep nuts and studs clean with no paint.*

Fig 1 Keel studs and nuts in painted bilge

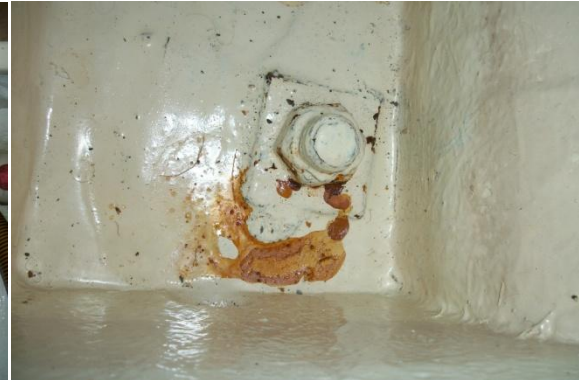
Fig 2 Keel stud and corrosion stain

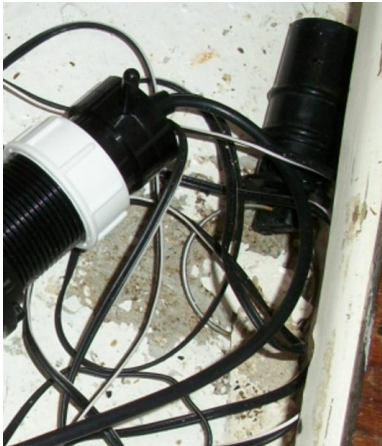
There was one exception to the above readings. In the bilge area aft of the sounder thru hulls, the paint inside is coming off and the fibreglass is deteriorating slightly. Readings on the inside here are high. The corresponding point under the hull is in line with the majority readings. This indicates to me that water has sat in this area of the bilge for some time and is permeating the grp from the inside. *This area should be thoroughly cleaned with acetone, any non-resin impregnated laminates ground out and depending on how much is ground away, grp mat and / or epoxy applied to same thickness.*

Fig 3 area aft of logs

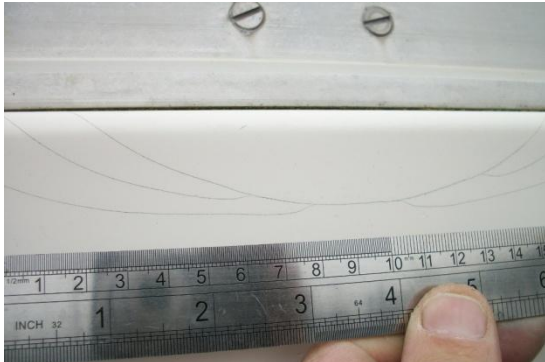
- a) Similar composition to below waterline but less layup of FRP will have been used.
- b) Top side moulding found fair and finished in the original white gel coat. The gel coat surface is in generally good condition with little UV degrading. There are a number of gel coat repairs visible on sides, bow and stern. There are also a number of scuffs and marks around the hull, none except noted expose any laminates.
- c) Gel coat crazing was noted port side below forward stanchion which is slightly bent. The toe rail is not damaged at this point. Approximately 150mm long.

Fig 4 Stress crazing starboard side.

This area could not be depressed with hammer handle and body weight. Because of its location it would indicate these have been caused by minor impact to the stanchion or directly to the hull. There will be damage to the laminate but there are no major loadings at this place. i.e rigging attachments. Moisture readings taken around the area do not indicate any water ingress yet. *I suggest they should be sealed to stop water ingress, either by waxing or a better repair would be to Vee out each crack and expertly flow coat and polish however I would recommend a professional to get the correct match and finish.*

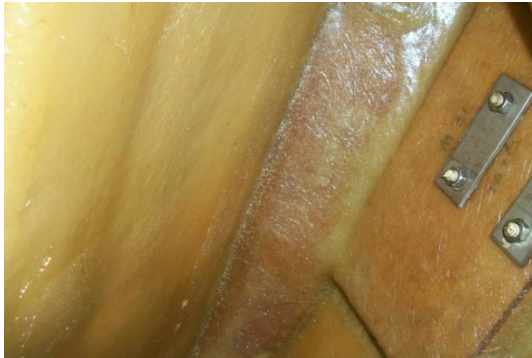
- a) The deck is of solid GRP with plywood laminated in for extra rigidity in places. Access to the underside was greatly restricted by headlining and only accessible from cockpit locker and in anchor locker.

Fig 5 Deck moulding showing plywood strengthening and plates under fittings

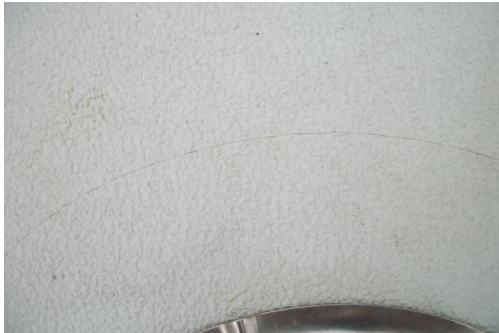
- b) The gel coat is white with moulded grey / blue non slip, there are no signs of pitting caused by UV or aggressive cleaning agents.
- c) There were marks in the non slip noted around all fittings that appear to be “Stanley” knife cuts. They are not stress marks as they overlap at the corners. These may have been on the boat from new or someone has cut something out on deck like a pattern for a teak deck. *These are unsightly and will be difficult to repair invisibly.*

Fig 6 Deck “cut” around vent

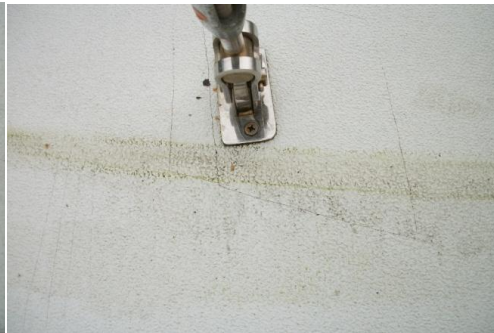
Fig 6 Deck “cut” around chainplate.

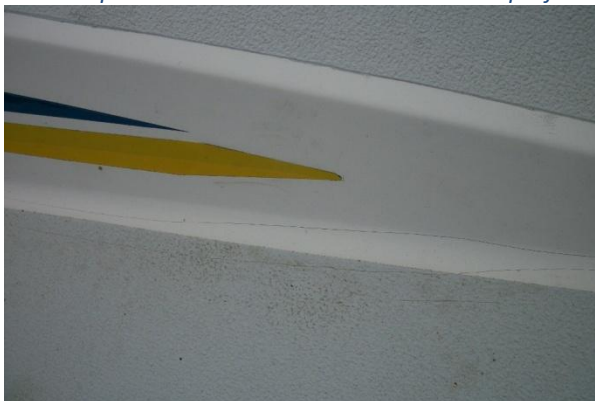
- e) Starboard side deck forward where deck joins cabin roof there are stress cracks in the gel coat. Moisture readings taken around the area do not indicate any water ingress yet. *I suggest they should be sealed to stop water ingress, either by waxing or a better repair would be to vee out each crack and expertly flow coat and polish however I would recommend a professional to get the correct match and finish.*

Fig 7 Stress crack starboard side deck

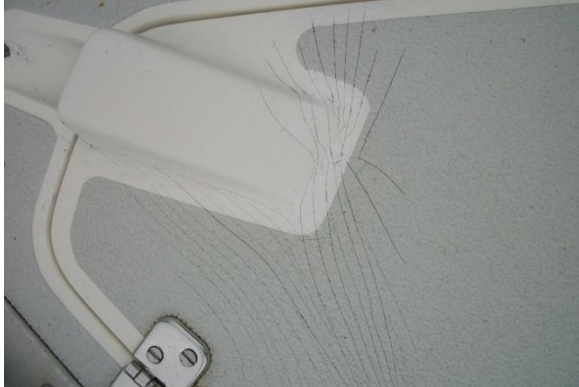
- f) The deck was lightly hammer sounded and moisture tested with no significant defects found except noted.
- g) Anchor locker lid is badly stress cracked probably due to anchor being dropped on it. *Suggest repair as e) above*

Fig 8 Stress crack anchor locker lid

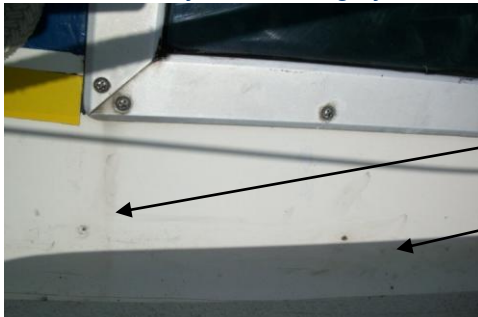
- a) Integral with deck moulding and constructed in the same way. The whole area was carefully tested underfoot and no sign of delaminating or other structural defect.
- b) The teak handrails were tested with a lever and while secure I felt that if I applied full body weight they would break. *Recommendation – Do not use teak hand rails for security unless replaced.*
- c) Two screws protruding from galley area paper towel holder. Water will enter laminate from here. *Remove towel holder and fill holes with gel filler.*

Fig 9 screws protruding through coachroof.

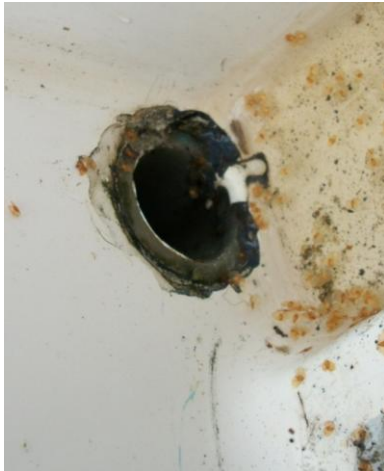
- a) Integral with the deck moulding and constructed in the same way. Two port lights into cabin and heads, removable transom seat with teak slates securely fastened.
- b) Deep locker to port has securely hinged lids and positive method of closure. Deep lip type.
- c) Gas locker to starboard aft.
- d) Cockpit table socket is lifting at aft end. This is cut into the floor and there maybe exposed laminate and wood edges which will suffer water ingress. *This should be removed and refitted with Sikaflex 291 marine sealant*
- e) Cockpit drains. At aft end of cockpit, they are GRP tubes bonded from inside. The edge in the cockpit has a sealant around under the gel coat which has caused the gelcoat to break up. *This should be cleaned out and either sealed with Sikflex 291 or flow coat gel repair to prevent water ingress into GRP laminates.*

Fig 10 Cockpit drain gel coat breakdown.

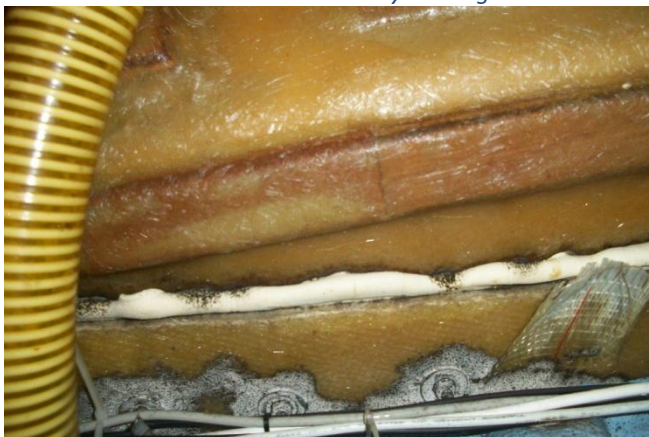
- a) This is mechanical type. The hull is moulded with an internal flange, the deck moulding sits on top of the hull moulding. The joint is filled with a hard bonding paste. This is through bolted with stainless steel screws, nuts and washers. The aluminium toe rail sits on the deck and stainless steel bolts go through the joint and secured with stainless steel nuts and washers. Occasionally a mild steel washer has been used which will corrode. *While individually no longer a structural item, where seen they should be replaced.*

Fig 11 Hull and deck joint

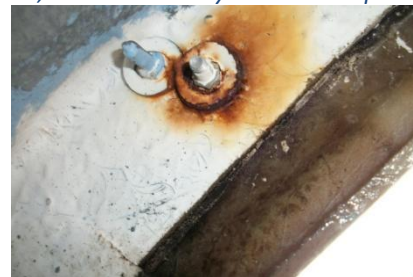
Fig 12 Hull and deck joint mild steel washer

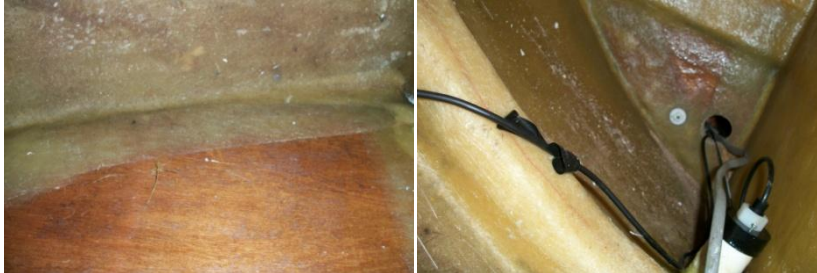
- d) The furniture is plywood and grp laminated to the hull and to each other and forms an integral part of the strength. All bonding is very good.

Fig 13 & 14 Evidence of good bonding and strength

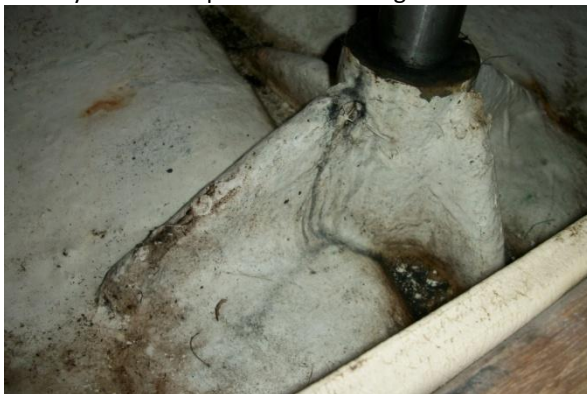
- e) Rudder tube is GRP and bonded to hull with substantial webs. They come just above the water line and have nylon seals top. There are no signs of leaks or cracks.

Fig 15 rudder tube

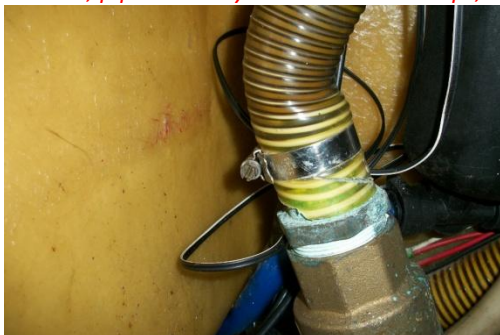
- a) Toilet outlet under saloon port berth. Yellow metal thru hull with yellow metal DZR ball valve. 1 clip, pipe spilt and kinked. Handle extended with sockets, still unable to turn. *Recommendation – DZR must be serviced, pipe correctly attached with 2 clips, and easy to operate before launch.*

Fig 16 Toilet outlet note kink in pipe, cut in pipe and single clip.

Recommendation – Toilet outlet DZR must be serviced, pipe correctly attached with 2 clips, and easy to operate before launch.

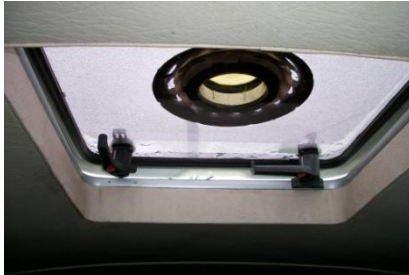
- a) Main companionway access hatch is of sliding GRP, in good condition and secure in its runner.
- b) Two wooden washboards in good condition, with vent. Slides in place in stainless steel runner and remain in position without companionway hatch being closed except in inversion condition.
- c) Saloon hatch Lewmar 250 x 500, hinged forward, secure means of closure and gasket intact. Worn Hinges will not allow hatch to remain open. *Hinge repair kits can be purchased through Lewmar.*
- d) Forepeak hatch hinged aft, gasket intact. Port catch clip missing. *Recommendation – hatch clip to be fitted before use in heavy sea. Hatch should be kept shut at sea due to hinge aft.*

Fig 17 hatch clip missing clip.

Recommendation – hatch clip to be fitted before use in heavy sea. Hatch should be kept shut at sea due to hinge aft.

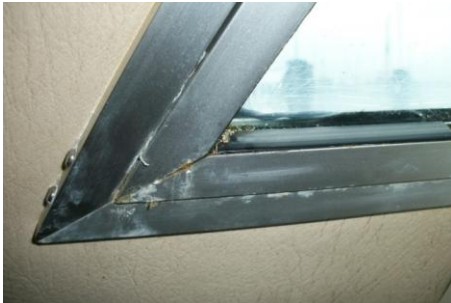
- a) 2 opening port lights in starboard aft cabin. Vetus make. Gaskets intact, secure method closure.
- b) Saloon portlights, original aluminium frames, stainless steel screws, evidence of leaks both sides due to gasket breakdown. *You can try and seal the leak with Sikaflex 291 but this is often unsightly. There is a good article here showing how to replace them with plastic windows.*
http://www.moodyowners.net/Technical_Library/documents/Moody_31_MkII_windows.pdf

Fig 18 leak port cabin window, starboard same.

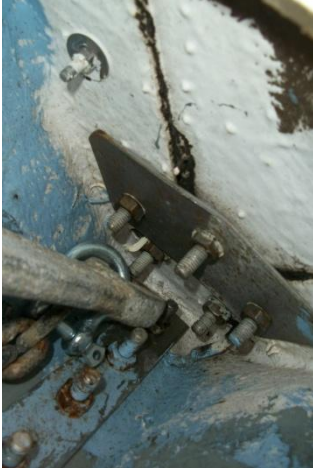
- + Main cap and lower shrouds attachment points. All attach to stainless steel chain plates that go through deck. No access to underside as behind teak ply wood panels with no access holes. They were tested with a substantial crowbar on wood block and no movement found. No sign of seepage via deck fittings.
- + Forestay attaches to stainless steel stem head with 3 bolts in sheer down stem and 5 in tension on deck. Large plate under deck. Hammer tested and levered where possible and no fault found.

Fig 18 Underside stem head fitting.

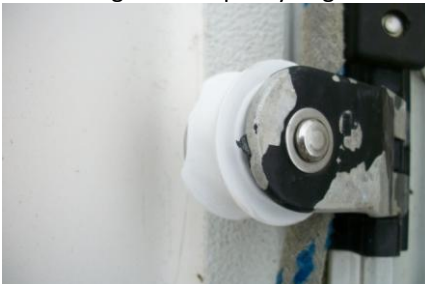
- a) All found of adequate size and securely through bolted, although inspection from under limited by linings.
- b) The following winches fitted were all tested as far as possible but not under load.
 - a. Coachroof, Lemar 8
 - b. 2 Lewmar 30ST – note self tailing plastic parts not fitted under stainless feeds. *Remove top of winches and locate correctly.*
- c) Starboard genoa car pulley edge broken off.

Fig 19 Genoa car broken

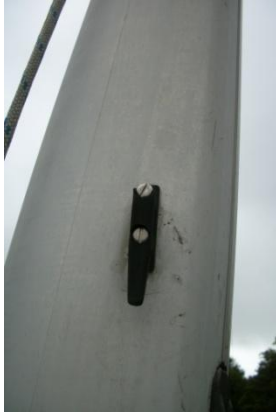
- a) Single spreader mast head rig. The mast was stepped so inspection is restricted to fittings and area to head height. It is Kemp mast, silver anodised no signs of corrosion around base or fitting. No damage or distortion to the extrusion was noted.
- b) Plastic cleat broken on port side.

Fig 20 Mast cleat broken

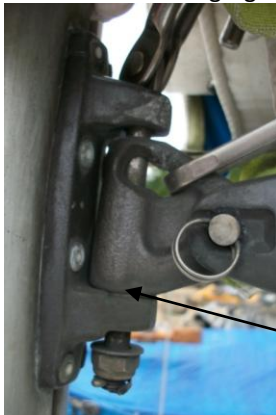
- a) Silver anodised in similar condition to mast.
- b) Main sheet and kicking strap attachment points secure as is the boom strut.
- c) Goose neck showing signs of wear at the base. *Suggest nylon bush fitted to take wear.*

Fig 21 Gooseneck wearing at base. Fit bush

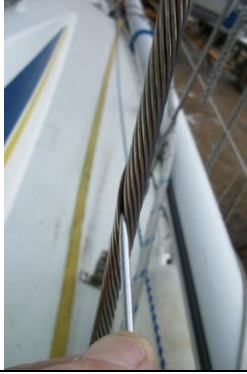
- a) As mast was stepped rigging could only be checked at deck level. These were examined where the wire enters the terminal under 10x magnification, no broken strands visible nor excess corrosion seen.
- b) The rigging screws are chrome plated bronze open bodied type and all had split pins securing them and had good articulation. All were found free from distortion or visible stress cracks, when examined under 10x magnification.
- c) Rigging all 1x19.
- d) Starboard lower shroud the outer wires are loose. The wire is under tension but the wires are loose, indicating that the wire has been over tightened. *Recommendation – starboard lower shroud must be checked by rig shop before sails are used.*

Fig 22 Starboard shroud unwound.

Recommendation – starboard lower shroud must be checked by rig shop before sails are used.

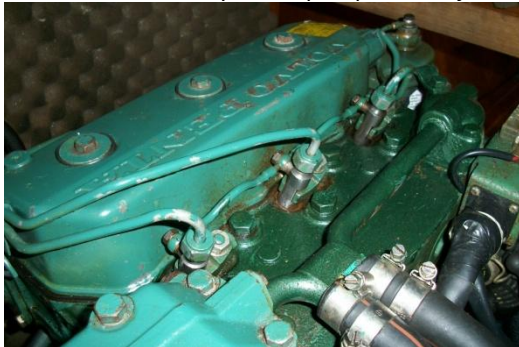
- a) Engine is generally clean and dry.
- b) Oil level in engine and gearbox correct although quite black and thick in engine.
- c) Engine is mounted on rubber mounts, tested with crow bar, good condition. No signs of corrosion and these bolted to grp engine beds, bolts all hammer tested and found secure.
- d) Starter motor, relays, lift pump and injectors all replaced evidenced by clean metal, not painted.

Fig 23 replaced injectors, painted head

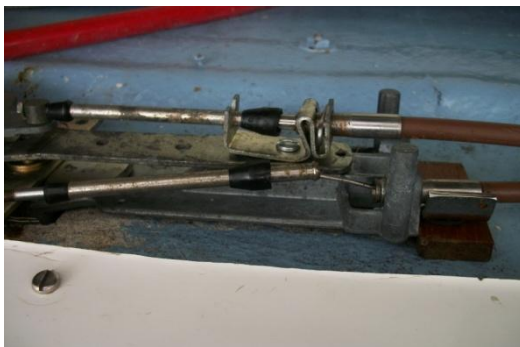
- e) New washers on diesel system
- f) Underside of engine original paint, no signs rust.
- g) Front bearer and top of cylinder head painted green Hammerite and evidence of rust in bearer where not painted.
- h) No evidence that cylinder block anode has been removed at anytime recently. *Check engine anode.*
- i) Exhaust pipes all securely clipped and water trap in locker clean and not rusty.
- j) No diesel leaks seen.
- k) Engine not seized, can turn over.
- l) TX control in cockpit, rear side is not protected and has been damaged. *Gear cable will need to be replaced and back of TX should be protected with grp cover.*

Fig 24 TX control not protected and cable broken.

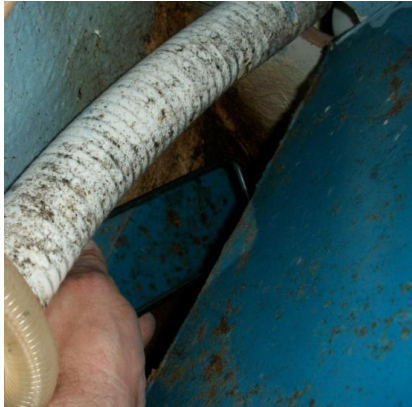
- a) Rubber hoses correct SAE100 fitted with swaged ends, all tested and found secure.
- b) Fuel tank of mild steel in cockpit locker. Surface rust on outside. Underside checked with mirror and similar to sides. Tank sits on bearers that keep it above any standing water. *Suggest tank is cleaned off and painted with red oxide primer or similar.*

Fig 25 fuel tank. Note mirror view underside
