## Marine Surveys UK

Survey Report no: [REDACTED]

Type of Vessel: Bavaria 39, FRP (fibre reinforced plastic), Bermudan sloop mono hull sailing vessel.

Type of survey: Pre-purchase

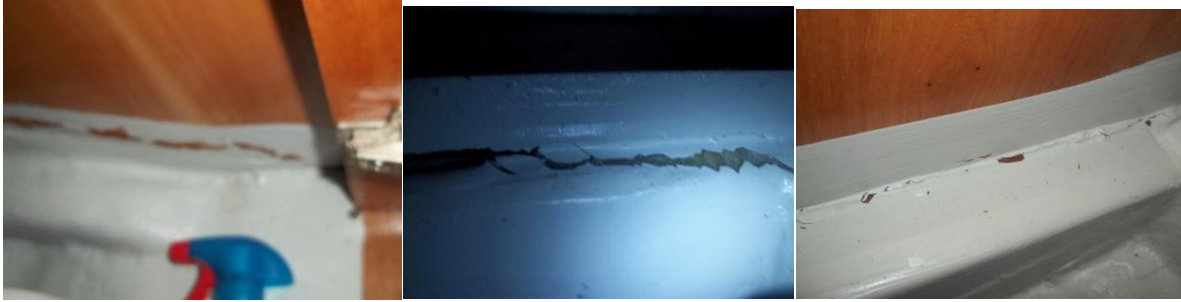
- a) The hull and deck mouldings are robust in the first place. There is an inner liner bonded to the hull which forms longitudinal and transverse box sections strength.
- b) Bulkheads were carefully hammer sounded near the deck, hull and floors for signs of debonding.
- c) All possible access was checked, lockers, under berths and the floors and inner mouldings for signs of delamination and cracks
- d) The masts loadings are transferred through the deck down a wooden King post on to the FRP box section floor below. The forward toilet door sticks a little when the boat is both in the water and also hanging in the slings.
- e) At the base of the forward bulkhead the grey gelcoat has cracked on the aft side. I was not able to insert a spike on the starboard side, I was able to insert a steel rule partially on the port side of the only as far as the laminate.

The pictures above are the aft side of the bulkhead. There are no other signs of any movement in any of the structure that was seen.

**Advisory notes:** while there has been some movement of the bulkhead, I believe this to be minor shifting. I suggest the base can either be painted over and if further movement happens then the base of this bulkhead could delaminating to the floor. The toilet door could be adjusted by a carpenter.

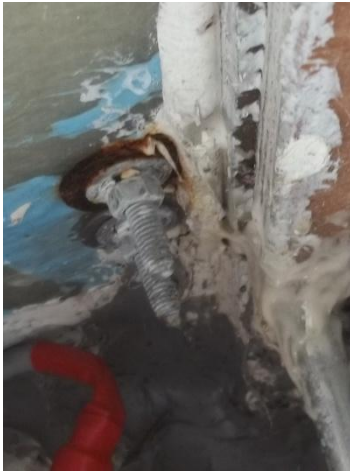
**Advisory note:** It was noted that some of the washers securing their fittings were mild steel and starting to corrode. See photo above. This is not currently an issue but would be wise to start to replace these when spotted.

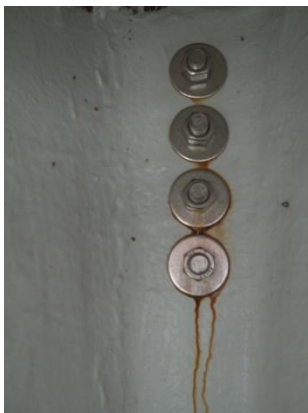
- a) The split backstay secures to stainless steel attaching points on the transom which are through bolted with a plate behind.
- b) The lower and main shrouds attached to a stainless steel plate bolted to the deck which in turn attaches to a stainless steel tie bar which is bolted to an FRP fixing laminated to the hull. (Called a Knee).
- c) The forestay attaches to a stainless steel chain plate bolted through the stem. There is a small corrosion stain in the anchor locker from this fitting.

**Advisory note:** the fixings was secure however this staining would suggest that a lower grade of stainless steel has been used and these fixing should be checked periodically and if the situation worsens then replace the bolts and nuts with 316 grade stainless steel.
