Marine Surveys UK

Survey Report no: [REDACTED]

Name of Vessel: "[REDACTED]"

Type of Vessel: Freedom 27

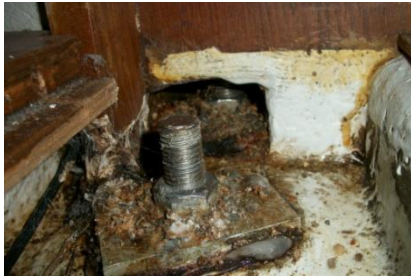
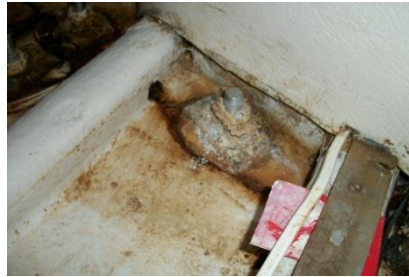
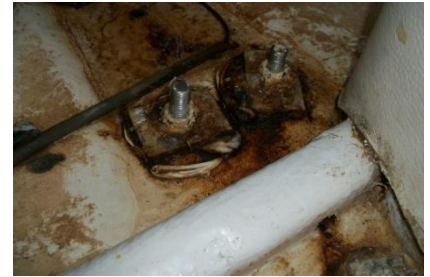
The wing keel is made of iron, bolted to the hull with stainless steel studs and nuts. The keel fits into a locating area of the hull. The keel is coated in anti-foul over many layers of old anti-foul, primer, fairing paste and possibly epoxy. As such the keel surface is uneven and not fair. The keel was hammer tested and magnet tested for voids. This showed that the appearance is cosmetic only. There are no signs of weeping at the joint with the hull although as mentioned there is a coat of anti foul applied since it came from the water. The keel was not tested in tension. The joint was spike tested for gaps and none found. Inside, I could only access the forward keel studs as the cabin sole was screwed down. The nuts are tightened onto alloy plates which are showing some signs of corrosion. The nuts were hammer tested and the plates scrapped and found to be surface corrosion on the plates only and the nuts sound. There is fresh water lying in this area, probably rain water which I suspect is causing this to happen.

Fig 2, 3, 4 Surface corrosion on keel stud plates

Suggestion - clean off alloy plates with wire brush and epoxy over nuts and studs. The cabin sole should be lifted to do the same to the remaining keel studs, plates and nuts.

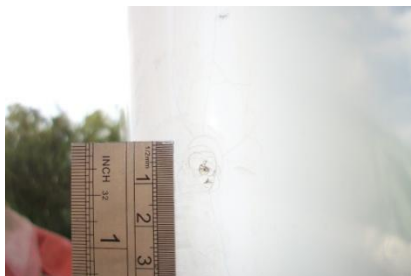
Fig 5 Minor stem damage

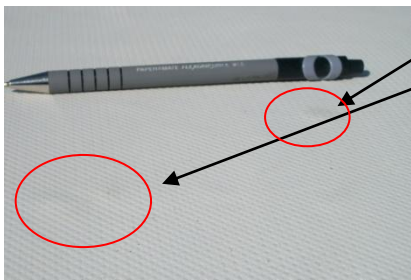
- a) Integral with deck moulding and with some areas of sandwich construction. All found firm underfoot with no sign of delaminating or other structural defect. There are 3 small raised areas which are solid and have no moisture reading. I believe these to be mould defects. i.e have been on the boat since new and are not a problem

Fig 6 Small defects on coach roof.

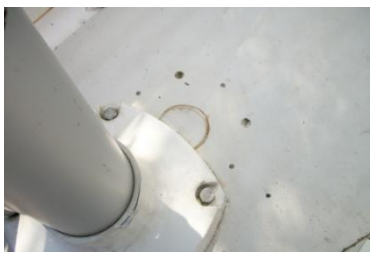
Fig 7 Repositioned steering

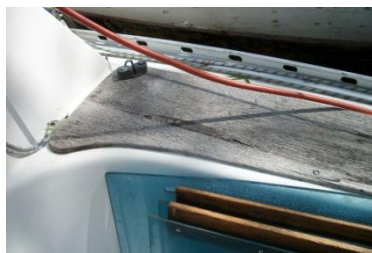
Fig 8 Teak ply coaming

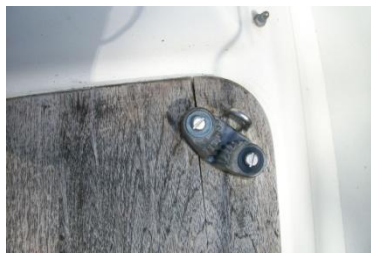
Fig 9 Teak ply coaming detail

- c) On both sides of the cockpit is a teak faced ply decorative panel. The Starboard one is delaminating and split at the forward end. This is held to the deck with screws. This is cosmetically poor and could cause splinters, also if the screws come loose water can ingress the balsa sandwich core and deteriorate over time. I suggest that this should be replaced or removed and the screw holes sealed / resealed.
- d) There is a 5 cm star crack in the gel coat to the port of the tiller knuckle. This should be ground out and gel coated to stop water ingress and for cosmetic purposes.

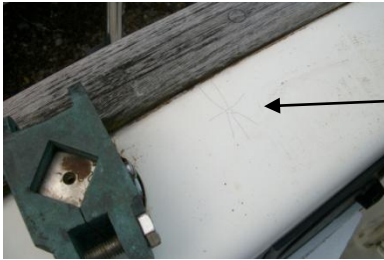
Fig 10 Repositioned steering

- e) It should be noted that to fit the steering the rear of the cockpit has been cut and a wooden cover fitted where the steering arm protrudes. This has compromised the watertight integrity of the cabin, which will be no problem in anything except extreme weather conditions, continued swamping of the cockpit or inversion of the vessel.

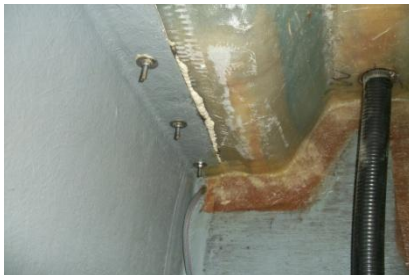
- a) This is mechanical type, through bolted via the toe rail bolts with s/s washers and nyloc nuts. Access to this is very limited by linings etc but where seen found in good condition with no signs of leaks. No stains seen elsewhere in the linings to suggest leaks. Toe rail of aluminium extrusion all lying fair with no signs of distortion due to collision or straining of stanchions, these being set in bases bolted through toe rail. The anodising is intact and in good condition.

Fig 11 Hull and deck join and bonded

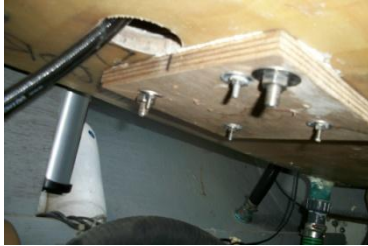
- d) There is no undue play in the bearings
- e) Rudder tube is GRP bonded into the hull and then again at the top of the cockpit. This has been cut to allow the hydraulic steering to be attached and the top and bottom rebounded to the cockpit coaming. The work appears sound and no movement is found in the tube. The cut is well above the waterline.
- f) As previously mentioned an aftermarket Vetus wheel steering hydraulic unit has been fitted which operated very smoothly. It has been attached with s/s bolts through the cockpit floor, through a marine ply pad and s/s washers. I could not move the pedestal with full body weight applied, the attachment appears good.

Fig 12 Steering pedestal attachment

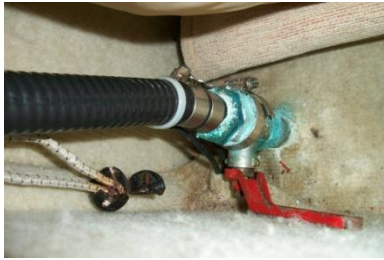
- a) Toilet outlet: Bronze thru hull with DZR ball valve. 2 clips on pipe. Currently shut and not possible to turn. It may well free up with cleaning from outside *Recommend freeing up before launch.*
- b) Heads water inlet. Bronze thru hull, with DZR ball valve. Lot of green corrosion and stains. 2 clips on pipe and a 3rd clip around the valve. Not sure why. Stiff but works. *Recommend clean up and further investigation into why 3rd clip fitted.*

Fig 13 Toilet inlet 3rd clip

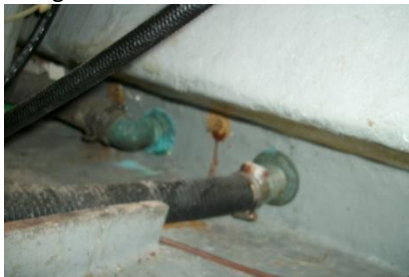
- f) Manual bilge pump bronze thru hulls, no valve, located just above waterline. 2 clips.
- g) Exhaust thru hull is bronze with bronze 90 degree bend. 2 clips.
- h) Cockpit drains. 2 bronze through hulls. Securely fitted 2 clips. Port clips corroded but sound. Suggest change in next 12 months

Fig 14 cockpit drain clips

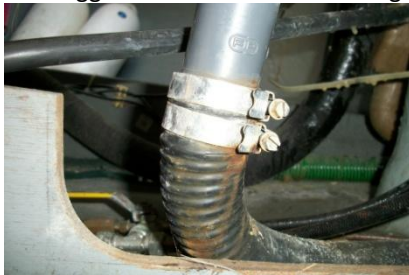
- i) Where attached to cockpit floor drain there are plastic extensions with 2 clips. Port drain has both clips fitted in same direction. Best practice is to have them in opposite direction. Suggest change around 1 clip. Also suggest care taken when storing fenders etc in lockers that plastic fittings are not damaged.

Fig 15 cockpit drain clips same direction

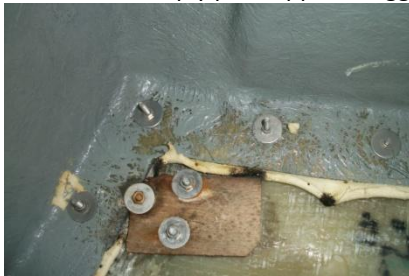
- a) Pulpit. Bolted to deck with stainless steel nuts and bolts with washers underneath. All tested with full body weight and visually checked. In good condition and secure.
- b) Pushpit. Bolted to deck with stainless steel nuts and bolts with washers underneath. All tested with full body weight and visually checked. Port aft fixing slightly raised and on checking fixing underside slight deterioration in ply pad support. Suggest ply pad changed in next 12 months.

Fig 16 Push pit ply pad

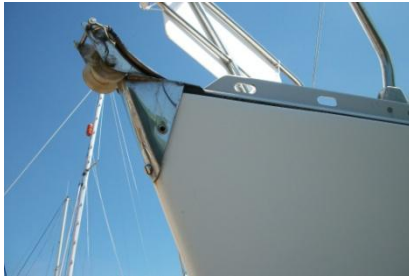
- b) No other anchors found.
- c) Stemhead fitting is stainless steel secured through deck with s/s bolts. Hammer tested and no sign of damage. Single bower roller and has pin to prevent the chain jumping in rough conditions. One bolt is missing which should be replaced.

Fig 18 stem head bolt missing.

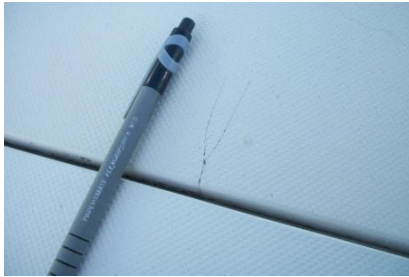
- f) There anchor locker lid has no means to keep closed except gravity and so may open and close in rough seas. The lid has a small crack in the centre aft. Suggestion. A simple bronze bold can be fitted. And the lid repaired by laminating underneath and filled with gel coat.

Fig 20 Anchor lid crack

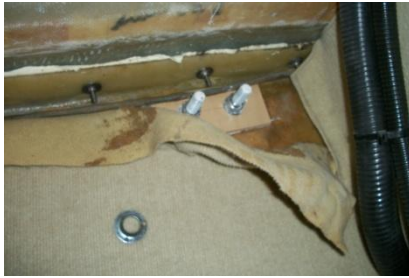
- a) Vessel fitted with folding stainless steel boarding ladder with 4 steps extending below water line for easy boarding from water. No signs of wear and secure when pulled and climbed on.
- b) 2 Beaching post supports have been fitted to either side of hull. The bolts and nuts are of adequate size. I would suggest the washers should be increased in size.

Fig 21 Beaching posts internal fitting

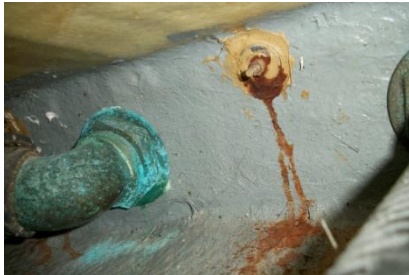
- c) There is an outboard bracket securely attached to the transom that can be used for emergency propulsion with outboard attached.
- d) Some of the washers used to attach ladder to the transom are mild steel and rusting. These should be replaced over next 24 months.

Fig 22 Mild steel rust.

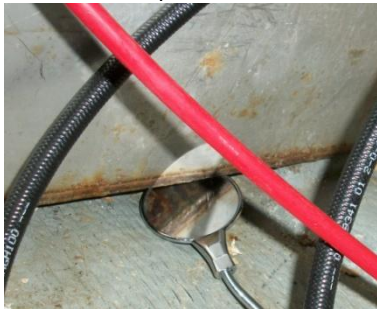
- a) Stainless steel tank fitted under cockpit floor. There is slight surface corrosion on the base which when tested with a spike was sound. This should be periodically checked.

Fig 23 Fuel tank underside check

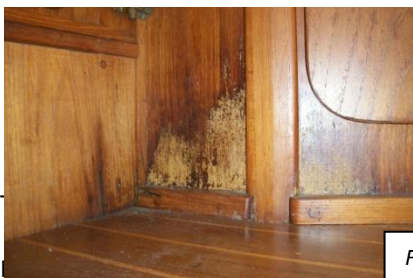
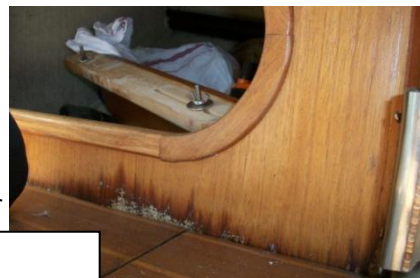
Kept clean, airy and light, good size galley. Upholstery in good condition. Lee cloths fitted in forward berths. There is a fresh water leak evidenced by water collecting in the bilge and around the mast base. I suggest that the water tank is removed, that area dried out and then check around mast base for leaks from deck, although there is no evidence of water running down the mast. It is possibly a leak from a water tank fitting although the base of all the berths and heads in the saloon show evidence of water ingress from below normally associated with wet bilge.

Fig 24 / 25 water ingress
