## Marine Surveys UK

Survey Report no: [REDACTED]

Name of Vessel: "[REDACTED]"

Type of Vessel: New build open motorboat constructed from FRP hull moulding with Plywood wheelhouse

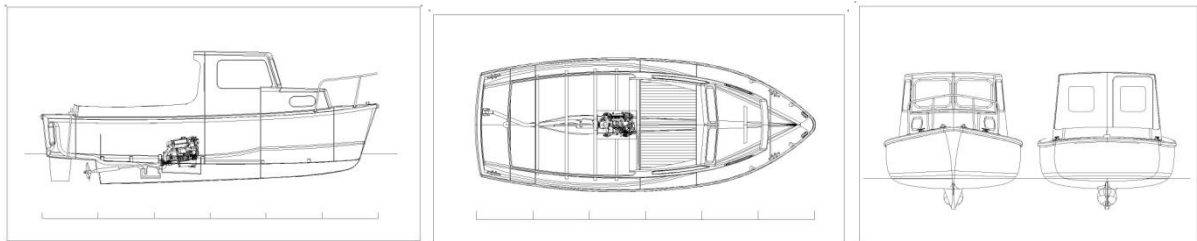
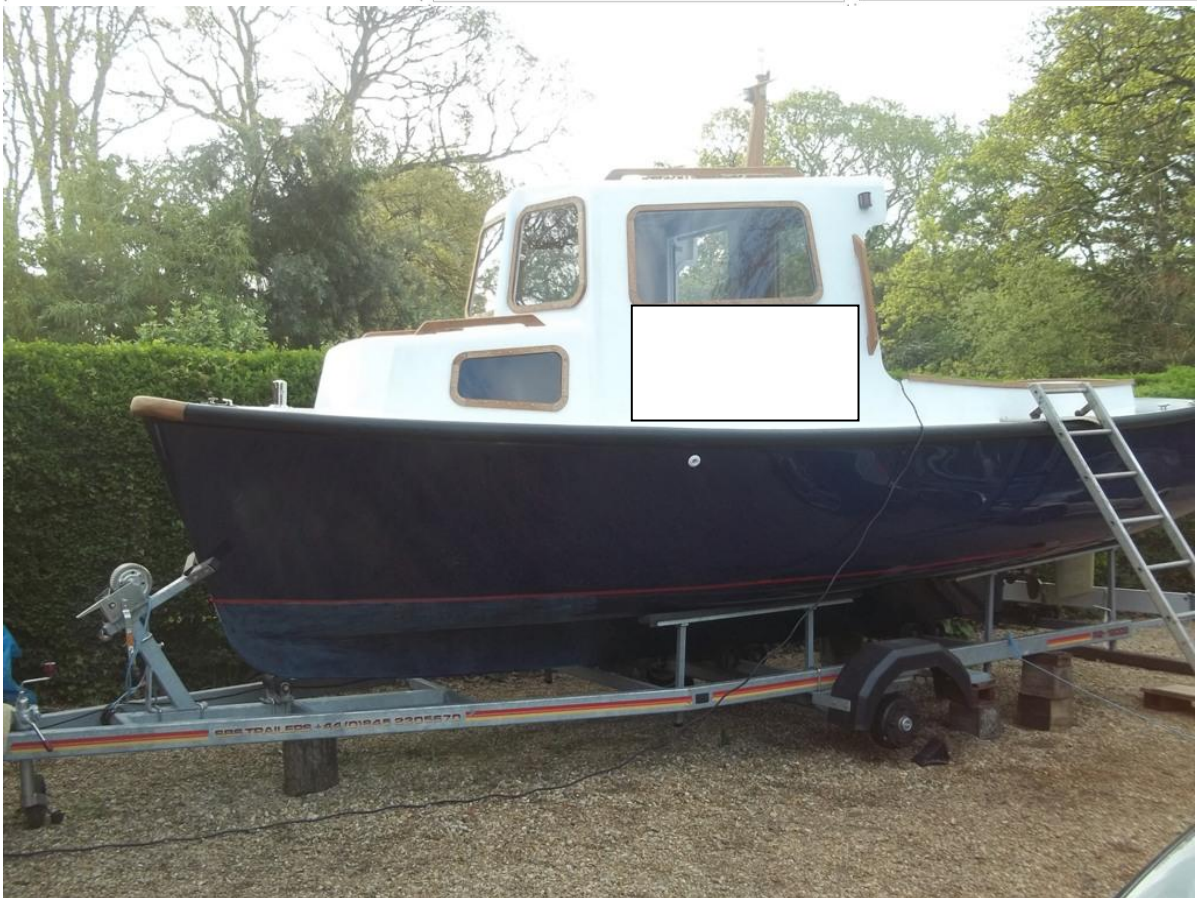
The lines of the craft and photo of vessel at survey.
