## Marine Surveys UK

Survey Report no: [REDACTED]

Type of Vessel: Colvic Countess 28

This survey was carried out on the [REDACTED] August 2010 at Langstone sailing club, Hampshire UK. The above named being the owner of the vessel.

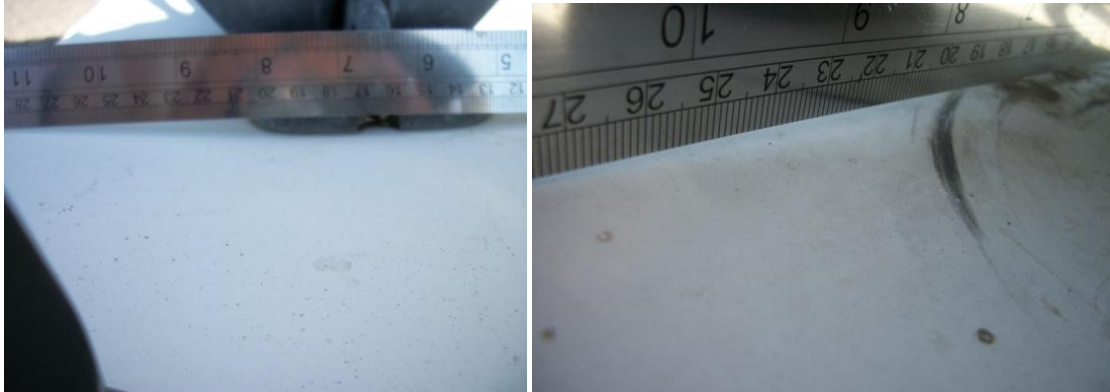
- a) Integral with deck moulding and constructed in the same way. The whole area was carefully tested underfoot and no sign of delaminating or other structural defect.
- b) There is a depression around the mast foot, 8mm at its maximum. There is slight flexing of the coach roof area below the mast when the shrouds were flexed. Moisture readings were taken in this area and they read 32- 36 shallow and 36 deep. This indicates moisture is present. The headlining panel below the mast was removed and there is a plywood pad laminated in the deck below the mast. A metal spike could be

inserted into the pad where various wires are fed through the deck up to 4mm only. The king post top plate, made from stainless steel, is not flush to the underside of the deck and there are no wedges present. The king post is not distorted and the wooden pad, laminated into the hull below the king post was hammer tested and moisture tested with no indication of failure.

Fig 1 -2 Depression around mast base on coach roof and aft

*Recommendation – In the short term, hardwood wedges should be inserted between the kingpost and the deck after slackening the rigging off. Once inserted, the rigging can be re-tensioned. The cables should be sealed above deck only to stop any further water ingress. In the next convenient period and before any heavy weather sailing is undertaken the plywood pad should be strengthened with resin or replaced.*

- ✚ *Recommendation – In the short term, hardwood wedges should be inserted between the kingpost and the deck after slackening the rigging off. Once inserted, the rigging can be re-tensioned. The cables should be sealed above deck only to stop any further water ingress. In the next convenient period and before any heavy weather sailing is undertaken the plywood pad should be strengthened with resin or replaced.*

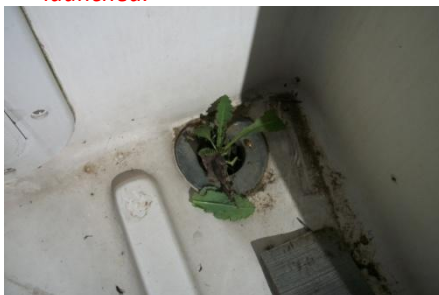
- a) Integral with the deck moulding and constructed in the same way.
- b) 2 cockpit drains at aft end. The cockpit drains have weeds growing in them.

Fig 4 weeds in cockpit drains

*Recommendation – Cockpit drains must be cleared and made free flowing. To be carried out before boat is launched.*

- ✚ *Recommendation – Cockpit drains must be cleared and made free flowing. To be carried out before boat is launched.*

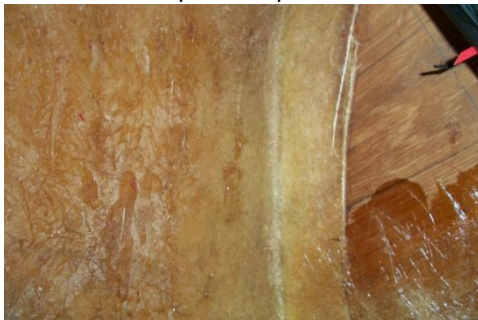
- a) There are a number of bulkheads and floors bonded to the hull throughout the length of the hull. Where seen the bulkheads and floors are well bonded with no signs of movement or cracking found. (Floors in this case are plywood panels on either side but not continuing full height to deck level).
- b) Wooden bulkheads were tested with moisture meter. Discrete spike testing showed no deterioration in wood. The main bulkheads has been Formica covered in heads area, and the top edges on the other side are covered with headlining panels. The edges were tested where possible with a spike which could not be inserted.
- c) The cabin sole access panels were all lifted and checked below but much of the sole area is covered with screwed down panels.
- d) Please note compression post comments and recommendations in section 6 above

Fig 5 Well bonded floor panels

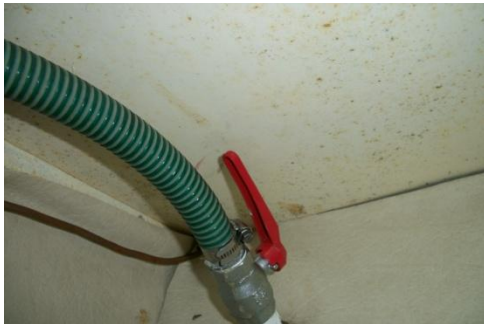
- a) Engine seawater inlet: Bronze thru hull and strainer with DZR valve.
- b) Galley sink drain: Bronze metal thru hull, with DZR valve. Single clip only. Cannot close due to location. Suggest second clip fitted. *Recommendation – DZR needs turning on thru hull so can be closed.*

*Fig 6 galley drain handle fouling cupboard top.*

- ✚ Galley sink drain: Bronze metal thru hull, with DZR valve. Single clip only. Cannot close due to location. Suggest second clip fitted. *Recommendation – DZR needs turning on thru hull so can be closed.*
- ✚ Toilet outlet: Blakes Seacock. Single clip only and hose not fully fitted although secure. Could not turn. *Recommendation – free off and fully fit hose before valve is opened.*
- ✚ Gas locker drain – plastic thru hull with gate valve. Thru hull cracked and when tested end came off. Pipe also contaminated so may not be clear *Recommendation – replace thru hull before launch and clear pipe before using gas bottle stowage locker.*

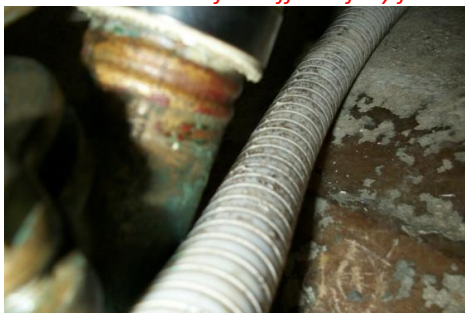
- c) Heads water inlet: Blakes Seacock, bronze bolts. Single clip only. Suggest second clip fitted.
- d) Toilet outlet: Blakes Seacock. Single clip only and hose not fully fitted although secure. Could not turn. *Recommendation – free off and fully fit hose before valve is opened. Suggest second clip.*

*Fig 7 Heads outlet pipe not fitted fully on seacock.*

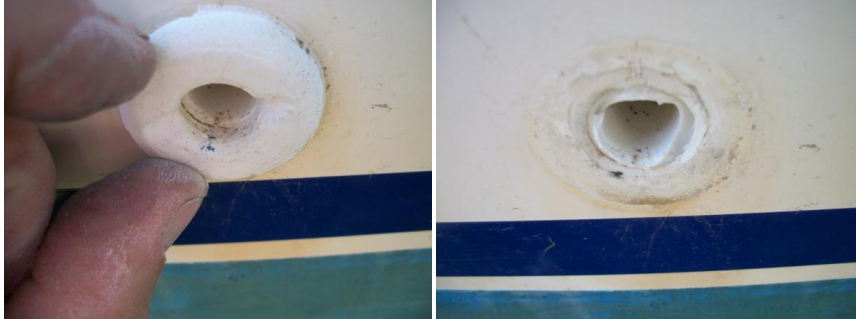
- f) Gas locker drain – plastic thru hull with gate valve. Thru hull cracked and when tested end came off. Pipe also contaminated so may not be clear

Fig 8 – 9 gas locker drain before and after testing

*Recommendation – replace thru hull before launch and clear pipe before using gas bottle stowage locker.*

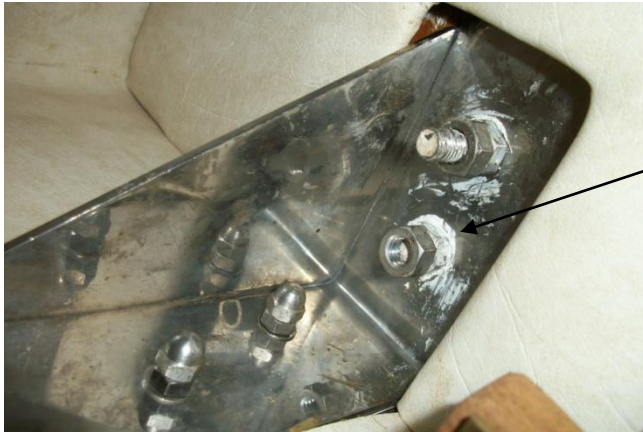
- a) Main cap shrouds attachment points. U bolt on side deck, 2 bolts in tension through to angle bracket bolted to knees. Starboard side the aft locking nut is only on with one thread. This is secure but suggest checked periodically.

Fig 10 Note lock nut is not securely on thread.

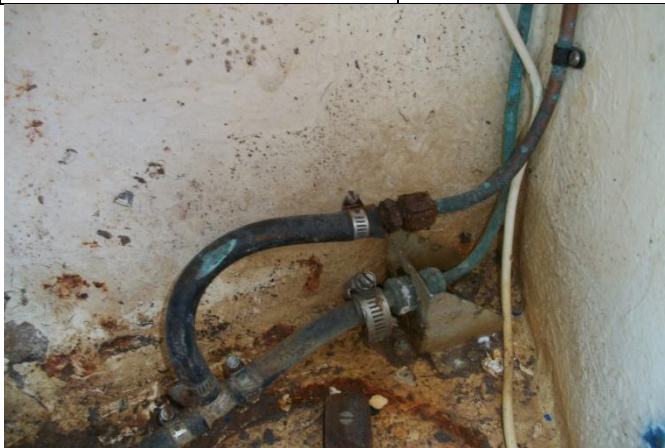
cleaned and it is only surface on pipes. Pipe fittings in gas locker corroded and one badly corroded.	
<b>Is pipework adequately supported and not under stress where accessible?</b>	Where seen in lockers it is laminated onto hull.	
<b>Are all appliances fitted with flame failure devices on all burners, and did these work properly under test?</b>	No flame failure devices on cooker. Cooker is old. Could not check heater.	<i>(S) Suggest change cooker for one with flame failure devices.</i>
<b>Are any appliances requiring flues properly fitted with same?</b>	Heater has exhaust exits but gas safe engineer should check.	<i>(R) Gas Safe engineer to check appliances.</i>
<b>Is a gas alarm fitted?</b>	Yes. Could not test as no batteries.	<i>(S) Test before relying on.</i>
<b>Is each appliance fitted with an isolating tap</b>	Yes.	
<b>If fitted did leak bubble tester function?</b>	Not seen	<i>(s) Consider fitting bubble tester.</i>

Fig 11 gas locker fittings corroded.

The system is as old as the boat and many fittings are corroded. *Recommend Gas safe engineer checks system before gas bottle connected.*

- ✚ *(R) Suggest replace with new BS standard marked gas hose and correct pipe clips.*
- ✚ *(R) replace .all fittings in gas locker*
- ✚ *(R) Gas Safe engineer to check appliances.*
- ✚ *Recommend Gas safe engineer checks system before gas bottle connected.*
