Survey Report no: [REDACTED]

Name of Vessel: "[REDACTED]"

Type of Vessel: Rowan Crown, FRP (Fibre Reinforced Plastic) Bermudian Sloop 24' sailing boat.

Type of Survey: Insurance Survey in water only

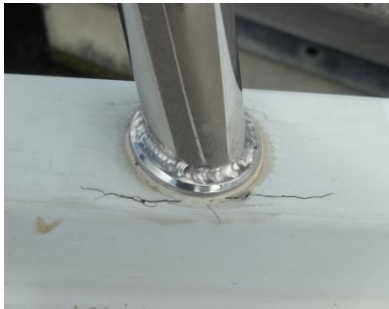
- a) The deck is of solid FRP, finished in off white gel coat with Treadmaster diamond pattern applied over most areas.
- b) The whole deck was carefully tested underfoot for signs of delaminating or other structural defects.
- c) The gunwale moulding around the stanchion bases and pulpit feet is cracked and the laminate broken on the starboard pulpit and aft posts being the worst affected.

- d) Moisture readings were 13 shallow with no significant increase on deep, which is considered dry for all practical purposes.

Advisory note: Gunwale around stanchion posts needs to be strengthened and sealed to prevent water ingress into laminates.

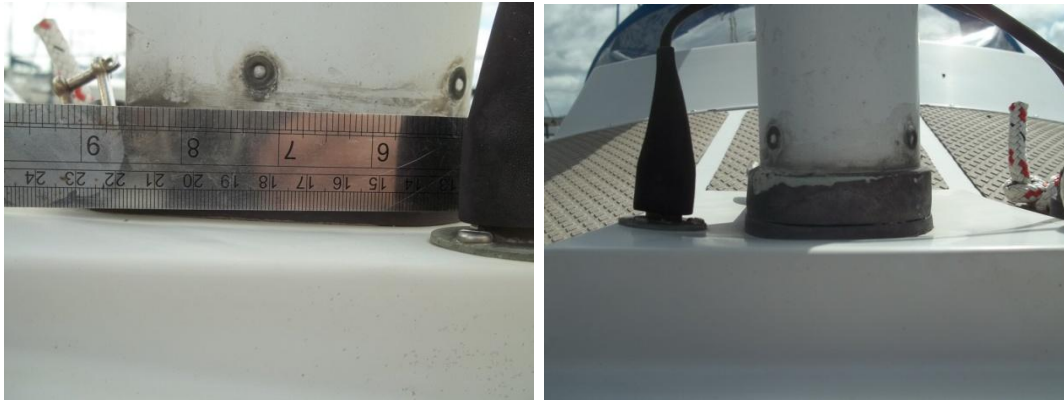
- a) Constructed as part of the same moulding as the deck
- e) The whole area was carefully tested underfoot for signs of delaminating or other structural defects.
- b) Hand rails were tested with a lever
- c) The area around the mast base has depressed approximately 8mm. I was not able to get it to depress further by putting pressure on the shrouds. Moisture readings were 26 shallow and deep, this would indicate that moisture has entered either the laminates of plywood pad moulded under deck. – **See section 9 for further information.**

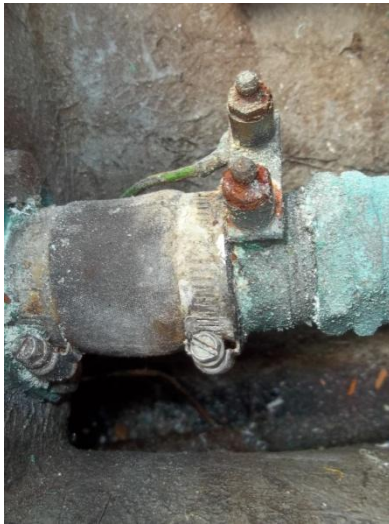
- a) This could only be accessed from the inside. There are some signs of corrosion around the stern gland fixings. These were struck with a hammer and found secure.
- b) The rubber joining hose from stern tube to gland is swollen at the forward end suggesting it is worn.

- c) No signs of water ingress.

Recommendation: Replace connecting rubber of stern gland and clips when the boat is next hauled or end of season which ever sooner.

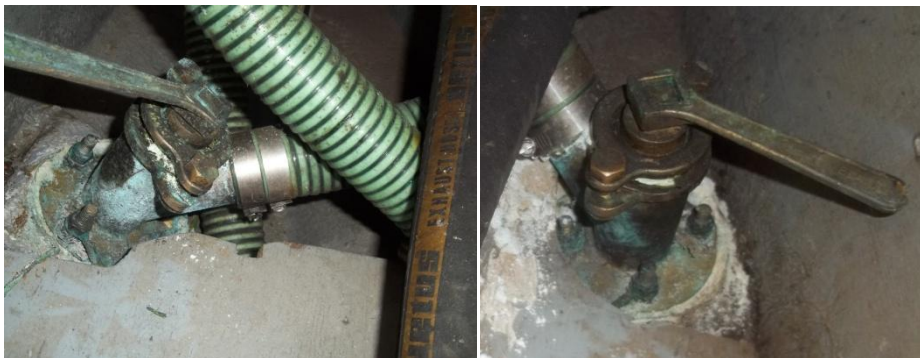
- a) Heads inlet – Blakes seacock – handle removed, T bar stored in heads to operate.
b) Heads outlet – Blakes seacock – handle removed, T bar stored in heads to operate.
c) Engine sea water intake, Blakes seacock – handle intentionally bent upwards.
d) Log cable in engine compartment
e) Cockpit drains x 2 Blakes seacocks – both have white powder residue from water and minor corrosion.

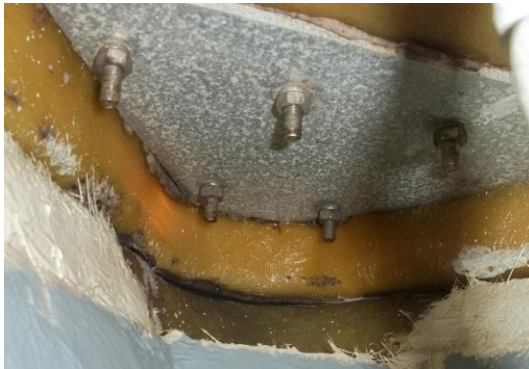
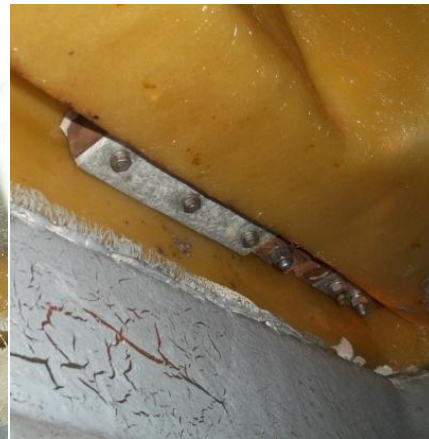
Underside stemhead and forestay fixing Underside starboard aft backstay fixing

Unless noted below, no movement found. No sign of seepage via deck fittings.

- a) Forestay attaches to stemhead fitting. Large fixing plate below deck and bolts securing.
- b) Back stay – U Bolts on aft quarters. – see photos next page.
- c) Shrouds forward and aft chainplates on side of coach roof, no access to inside to check

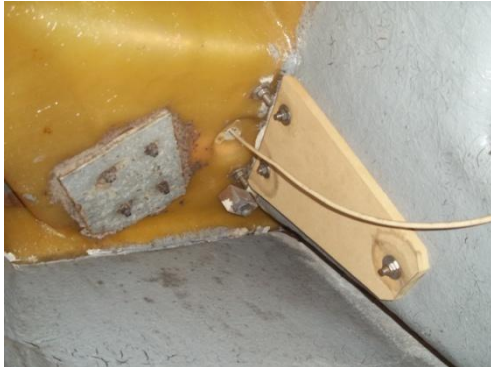
- a) Large stainless steel dinghy davits are secured with stainless bolts and nuts. No signs of corrosion. Backing plate is MDF which is not suitable for the marine environment and will deteriorate and fixing will come loose.

Recommendation: Replace MDF backing plate for davits with hard wood, marine ply or stainless steel backing plate before Dinghy is stowed at sea.
