Survey Report no: [REDACTED]

Name of Vessel: "not named"

Type of Vessel: 16' open sailing boat, with inboard engine, wood construction clinker type.

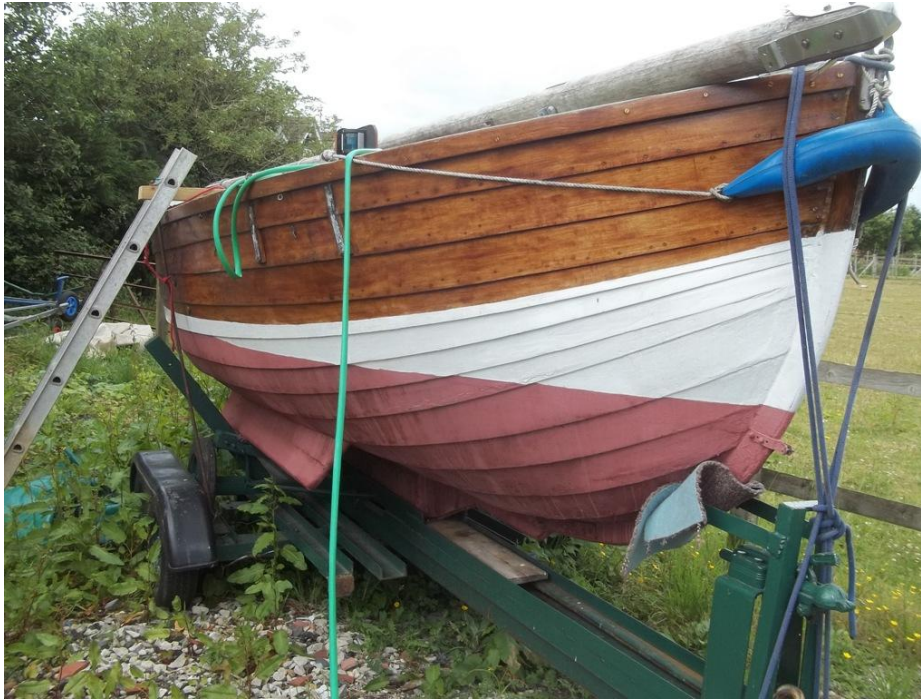
She is believed to be a one off design by was J.T Reynolds Designed and built. Dimensions were not gathered, she is approximately 16' in length.

Built as a sloop, possibly gaff rigged. There are no distinguishing marks to identify the type, builder or age.
