Marine Surveys UK

Survey Report no: [REDACTED]

Name of Vessel: "[REDACTED]"

Type of Vessel: Halcyon 27, FRP constructed, long keel, Bermudian Sloop rig sailing vessel. Circa 1970

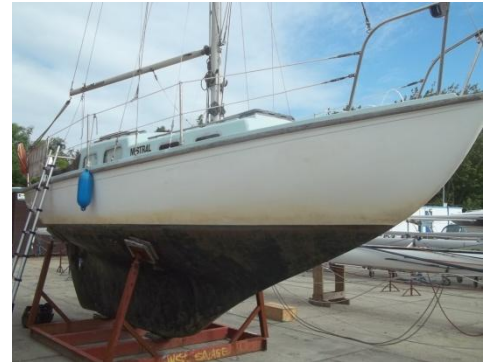
Length Overall	27'
Length of waterline	20'3"
Beam:	7'8"
Draft:	4'
Displacement	6720lbs
CE Specification	Built before requirement
