## Marine Surveys UK

Survey Report no: [REDACTED]

Type of Vessel: Prior Coaster 33, FRP construction,  
double mast ketch rig motor sailor.

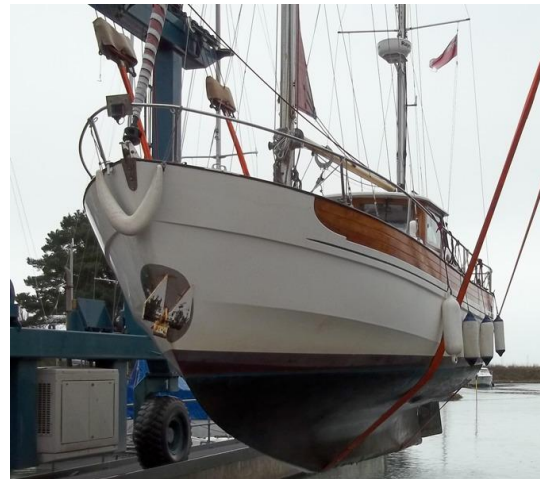
**Manufacturers’ information from owner association website (not verified by measurement)**

Length Overall	32’9” / 9.98m
Length waterline	28’5” / 8.66m
Beam:	10’2” / 3.10m
Draft:	4’ / 1.21m
Displacement	17,920lbs / 8,127kgs
CE Marked	no
