Survey Report no: [REDACTED]

Name of Vessel: "Not Named"

Type of Vessel: Kit built, Cat Ketch 17, Day sailor with twin un-stayed masts.

This survey was carried out on the [REDACTED] April 2011 at Port Solent Marina, Portsmouth, Hampshire UK. The above named being the owner of the vessel.

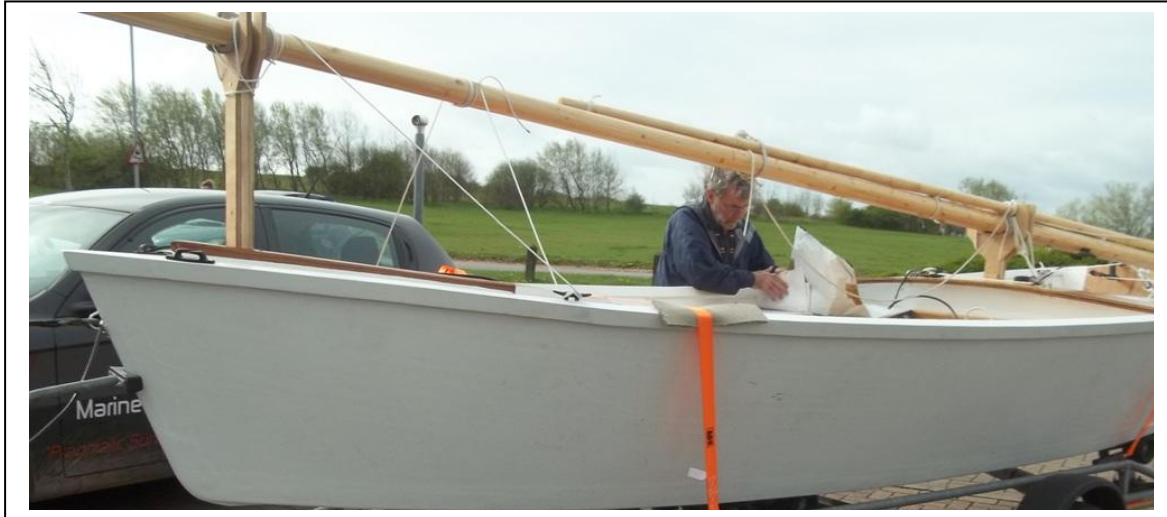
Built from plans by the owner from Marine plywood and over laminated. A ketch rigged Expedition 17'6" day sailing and exploration flat bottomed boat with unstayed masts and centre board.
